*TMS570LS31x/21x Microcontroller*

**Silicon Revision D**

# **Silicon Errata**

Literature Number: SPNZ222B  
March 2015–Revised May 2016

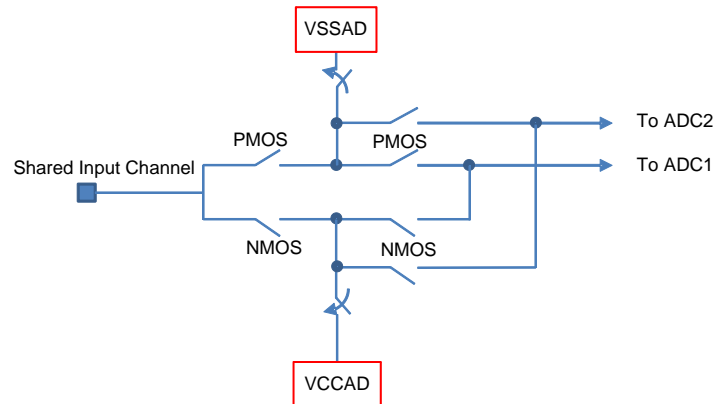
**Figure 2. Shared Input Channel in "Open" State**

The PMOS and NMOS switches are open indicating that this shared input channel is not currently being sampled either by ADC1 or by ADC2. Also, there are switches to VCCAD and VSSAD that are closed. If any current is injected into this analog input, any leakage through the open PMOS switch will be shunted to VSSAD. These switches to VSSAD and VCCAD are opened as soon as this shared input channel is being sampled by either ADC1 or ADC2.

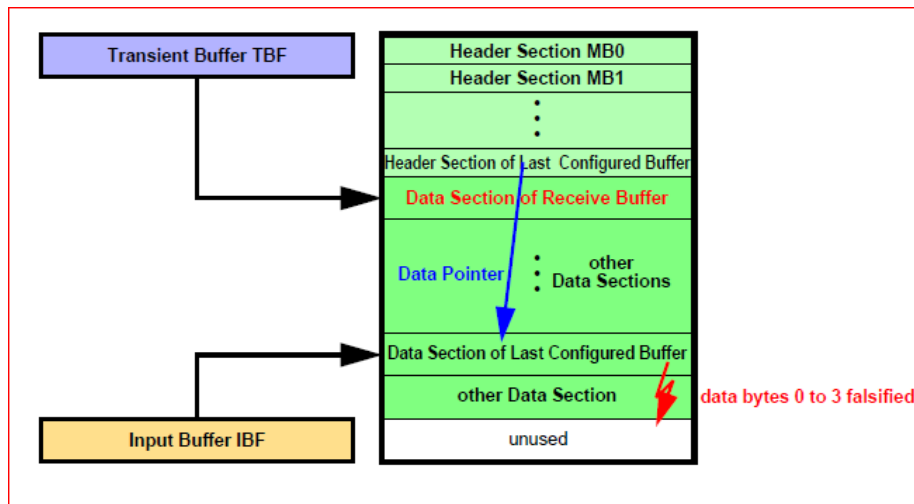
Figure 5. Second Fail Mode

- 2) When a message is transferred from IBF to the Last Configured Buffer in the Message RAM, it may happen, that at the end of the transfer of the Data Section one additional write access overwrites the following word, which may be the first word of another message's Data Section in the Message RAM (see Figure 5).
