**TMS320DA708,
TMS320DA708B
Digital Signal Processors
Silicon Errata**

Silicon Revisions 1.2, 1.1

SPRZ236C
November 2005
Revised October 2008

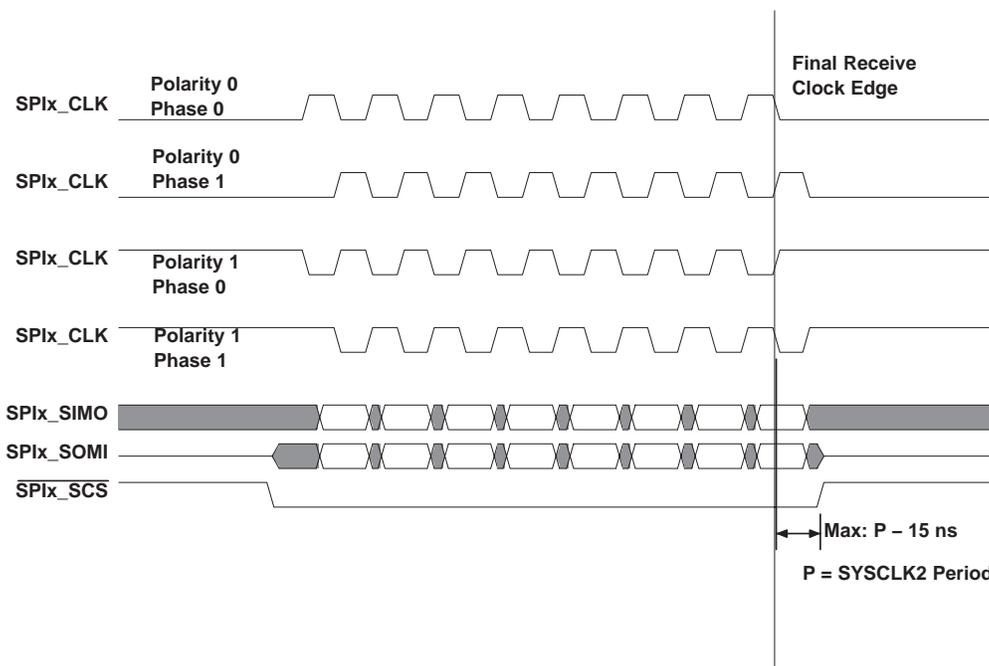
Figure 7. Timing Requirement of $\overline{\text{SPIx_SCS}}$ De-assertion in Four-Pin With Chip-Select Mode

Figure 7 illustrates the timing requirement on the de-assertion of the $\overline{\text{SPIx_SCS}}$ pin in the four-pin with chip-select mode. If the master does not meet this requirement, the slave will enter the transfer state again and receive the next word transferred on the SPI bus as well as consume any data already written to the transmit buffer.

Note that in most cases, the device system clock (P) is between 6 ns to 8 ns and the delay is negative. This means the master must actually de-assert the $\overline{\text{SPIx_SCS}}$ pin before the final receive clock edge. But the slave also 3-states its SPIx_SOMI output when $\overline{\text{SPIx_SCS}}$ is de-asserted, so the master may not be able to receive the final data bit correctly if it de-asserts $\overline{\text{SPIx_SCS}}$ early. (Timing requirements of SPI master devices vary; so, consult the data sheet of the particular master.)

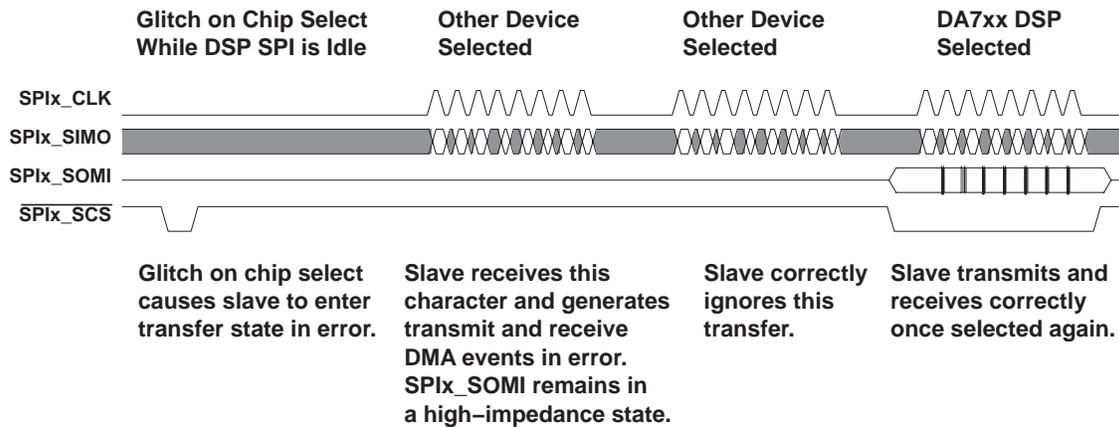
Figure 9 illustrates the case where the slave SPI captures a glitch on the chip-select line and enters the transfer state erroneously. If transfers to another slave device follow this event, then the DA7xx slave will erroneously receive the first character transmitted to the other selected slave device. Since $\overline{\text{SPIx_SCS}}$ is de-asserted, the DA7xx SPI holds its SPIx_SOMI pin in a high-impedance state and does not interfere with the data transmitted back to the SPI bus master by the selected slave device. After the erroneous transfer completes, the slave remains idle until the next assertion of $\overline{\text{SPIx_SCS}}$. (See Figure 11 for the case where there are not enough clocks to complete the erroneous transfer.)

Figure 9. Glitch on Chip Select Causing Erroneous Transfer

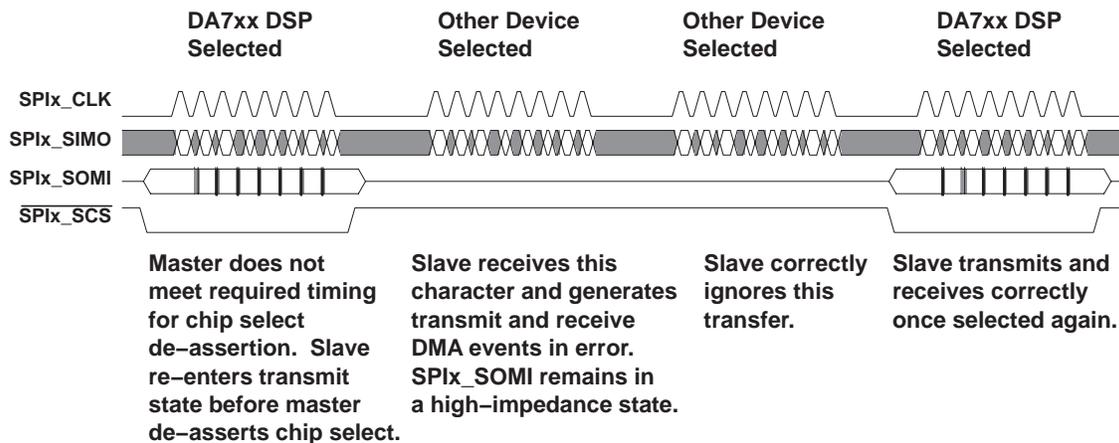
Figure 10 illustrates almost the same case as Figure 9, except the slave device enters the transfer state due to the master failing to meet the timing requirements for de-assertion of the slave $\overline{\text{SPIx_SCS}}$ input following a valid transfer as illustrated in Figure 7 and Figure 8.

Figure 10. Erroneous Transfer Due to Master De-asserting Chip Select Late

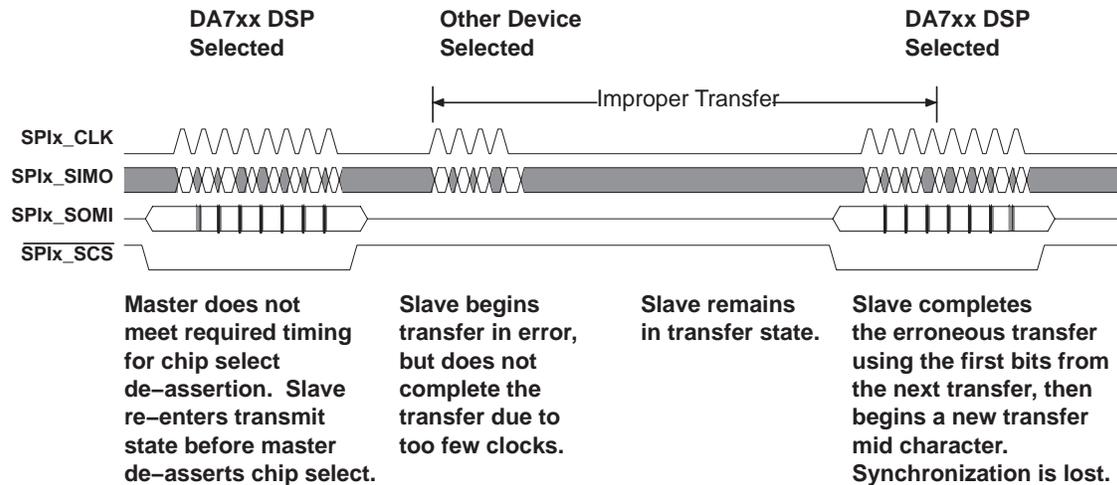
Figure 11 illustrates the case where the slave enters the transfer state in error due to the master de-asserting $\overline{\text{SPI_SCS}}$ too late to meet the timing requirements. (Note: the same issue applies if the slave device enters the transfer state due to a glitch on SPIx_SCS .) If there are not enough clocks for the completion of the erroneous transfer while the slave is deselected, the slave will remain in the transfer state. When selected, the slave will first complete the erroneous transfer using the first bits from the valid transfer. The slave then begins another transfer in the middle of the valid transfer, and synchronization to the master is lost. Data received while synchronization is lost will be invalid.

The slave will regain synchronization only after $\overline{\text{SPIx_SCS}}$ is de-asserted and there is a sufficient number of clocks on to allow the slave to complete an invalid transfer and enter the idle state before the master asserts SPIx_SCS again.

Figure 11. Loss of Synchronization to Character Boundary

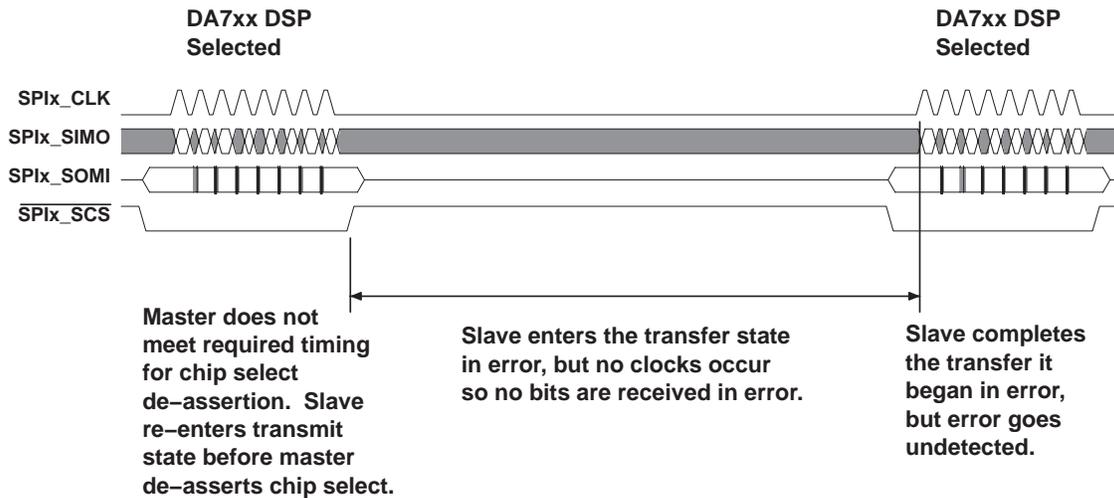
Figure 12 illustrates the case where the slave enters the transfer state in error due to the master de-asserting $\overline{\text{SPI_SCS}}$ too late to meet the timing requirements. (Note: the same issue applies if the slave device enters the transfer state due to a glitch on SPIx_SCS .)

If there are no clocks on the slave SPIx_CLK line while $\overline{\text{SPIx_SCS}}$ is de-asserted, then even though the slave is in the transfer state during this time period, no shifting occurs. This means that when the master selects the slave again for another transfer, this transfer will complete correctly. In four-pin mode, the error would go undetected. In five-pin mode, only SPIx_ENA remains a problem (see Figure 13).

Figure 12. Slave Enters Transfer State in Error, but Error Goes Undetected

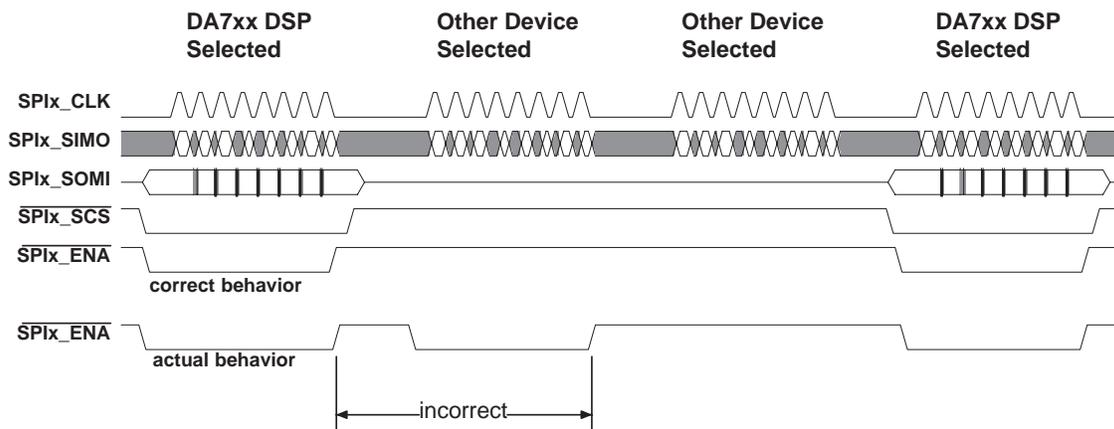
This will typically only cause a problem when sharing SPIx_ENA, since the de-selected slave may force the enable line to indicate ready even if the slave actually selected is not ready.

Note that Figure 13 illustrates the case where SPIINT0.ENABLEHIGHZ has been set to drive the SPIx_ENA pin in a push-pull mode. However, the same issue applies when configuring SPIINT0.ENABLEHIGHZ for open-drain mode, except instead of driving SPIx_ENA high as shown in Figure 13, the slave places the pin in a high-impedance state to de-assert SPIx_ENA.

The slave indicates its actual ready state while it is in the transfer state, even if it is in the transfer state in error due to the issues sampling chip select. This behavior is incorrect.

Figure 13. Slave Drives Enable Line Incorrectly During the Time it is in the Transfer State Erroneously

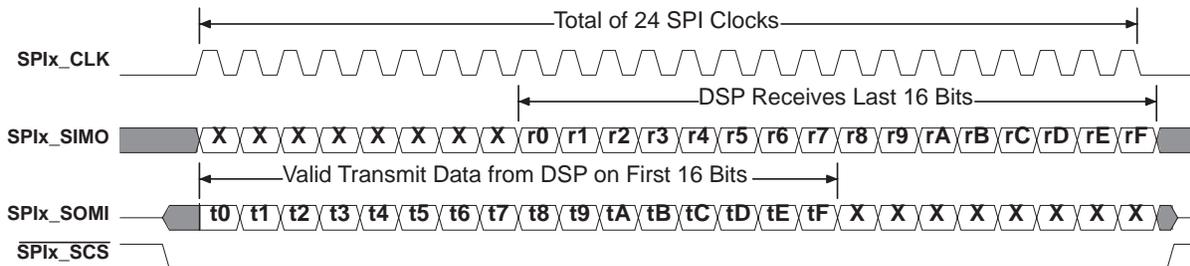
Figure 15. Slave SPI Operation With Character Length of 24 Bits

Figure 15 illustrates the operation of the SPI module in 3-pin mode with SPIFMT0.CHARLEN[4:0] programmed with a value greater than 0x10. In this case, the value of this field is 0x18 for a character length of 24 bits. This means that the slave SPI requires 24 clocks on SPIx_CLK to complete a single transfer. However, from an internal viewpoint, the slave only writes one 16-bit word to SPIDAT0/SPIDAT1 at the beginning of the transfer and only reads one 16-bit word from SPIBUF at the end of the transfer. As illustrated in Figure 15, the data written to SPIDAT0/SPIDAT1 will appear on the SPIx_SOMI pin during the first 16 SPI clock periods, followed by 8 indeterminate bits. Also, the data received in the SPIBUF register is the last 16 bits that appear on the SPIx_SIMO pin. The first 8 bits are shifted in but eventually discarded by the slave.

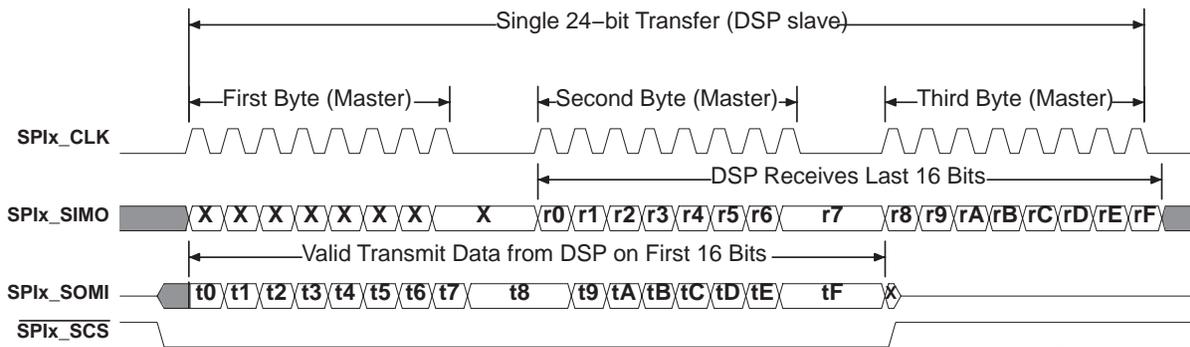
Master de-asserts chip select at the end of its second byte.

Advisory 1.1.2 issue now occurs at the end of the 24th bit. SPIx_SOMI is a don't care here.

Figure 16 illustrates the suggested workaround sequence, assuming that the SPI master is a microcontroller using an 8-bit character length.

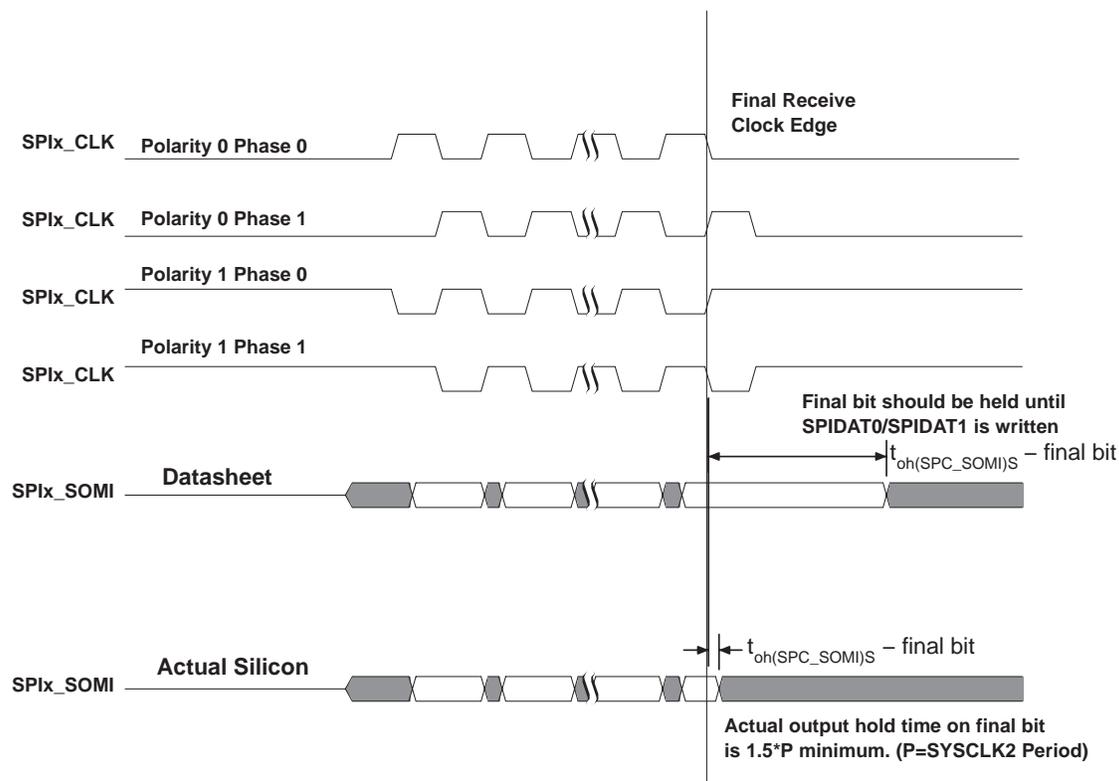
Figure 17. Actual Output Hold Time on Slave SPIx_SOMI Final Bit Versus Data Sheet

For the DA7xx device, this time is $1.5 \cdot \text{SYSCLK2}$ periods. With a typical SYSCLK2 period of 8 ns (based on 250-MHz SYSCLK1 and 125-MHz SYSCLK2), the resulting output hold time is only 12 ns.

Figure 17 illustrates the data sheet specification for the output hold time on the final bit (for the SPI in slave mode) versus the hold time on actual silicon.
