Errata

AM263x Sitara™ Microcontroller Silicon Revision 1.0A, 1.1

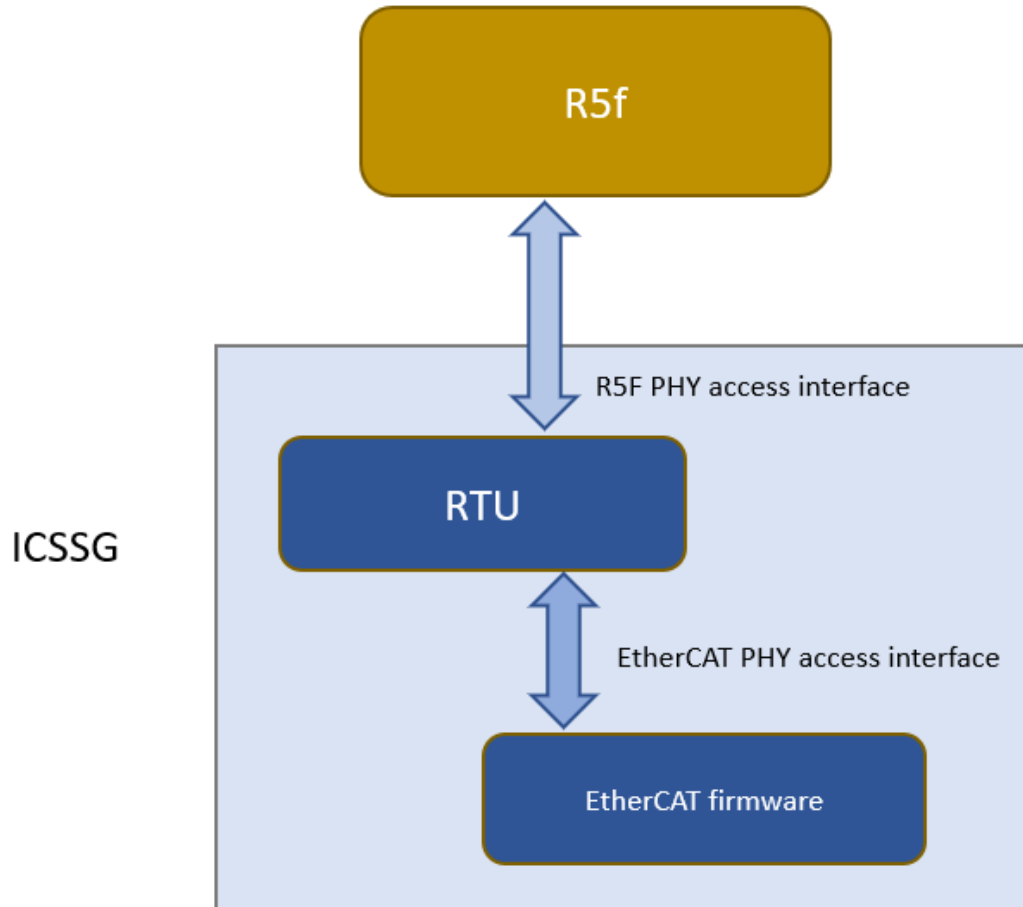
Figure 3-1. MDIO Emulation via Manual Mode using PRU Core

i2329 (continued) MDIO: MDIO interface corruption (CPSW and PRU-ICSS)

For EtherCAT implementation on PRU-ICSS, the software workaround will be done in RTUx/ TX_PRUx Core. The core will have to be dedicated for workaround, which means this can't be used for other purpose. The implementation will support two user access

channels for MDIO access. This provides option for R5f core and PRU core to have independent access channel. The APIs will be similar to the ones we will have in RTOS Workaround implementation.

EtherCAT will continue to use PHY fast link detection via MDIO MLINK bypassing state m/c for link status (as this path is not affected by errata). This makes sure that cable redundancy related latency requirements are still met.

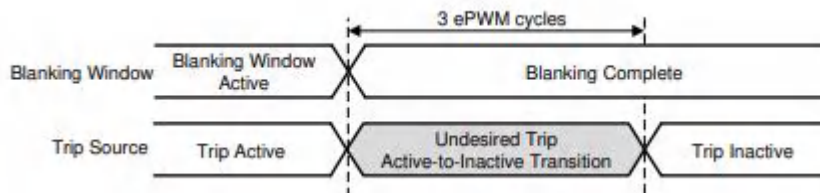
The blanking window is typically used to mask any PWM trip events during transitions which would be false trips to the system. If an ePWM trip event remains active for less than three ePWM clocks after the end of the blanking window cycles, there can be an undesired glitch at the ePWM output.

The following picture illustrates the time period which could result in an undesired ePWM output.

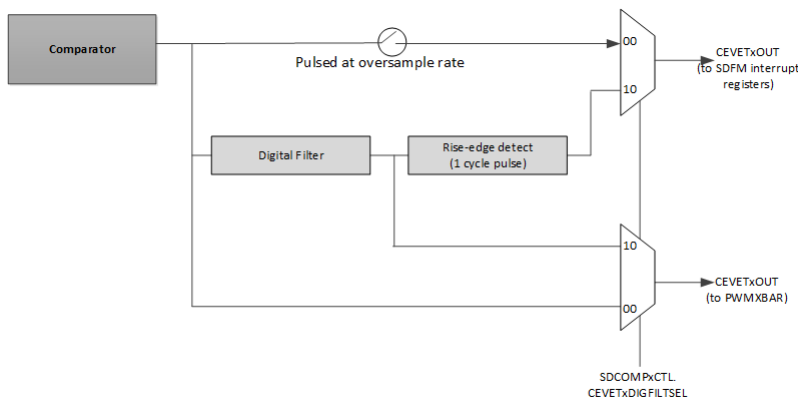
SDFM module event flags (SDIFLG.FLTx_FLG_CEVTx) do not get set again if the comparator event is still active and digital filter path (using SDCOMPxCTL.CEVTxDIGFILTSEL) is being selected

If SDFM digital filter is used in application the following workaround options can be considered:

- **Option 1**
 - XBAR status can be observed instead of the event flag register.
- **Option 2**
 1. After selecting the digital filter, wait for the interrupt/Trip.
 2. When the interrupt occurs, read the event flag and take appropriate application action to rectify the cause of comparator trip.
 3. Before clearing the event flag register, program the unfiltered path.
 4. Clear the event flag.
 5. Read the event flag and if it stays cleared for at-least one oversampling duration, reprogram the digital filter path.

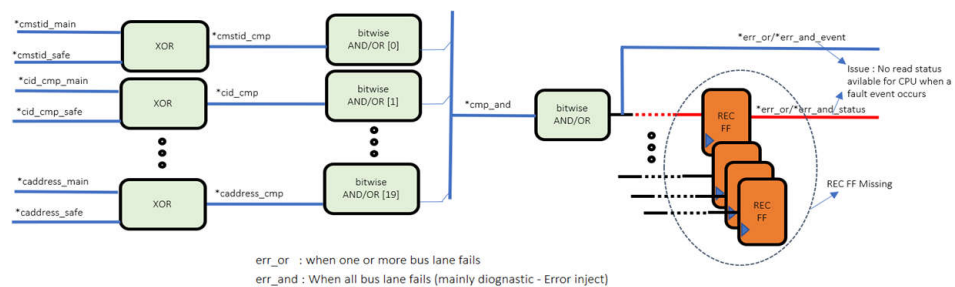
Figure 3-2.

Case 2: Log Registers have all zeros

Here the granular logs are not captured correctly and possible entities affected are R5F and L2 memory.

Case 2: In the case where the logs are not captured correctly then for a) diagnostics no action needed and b) in case of actual failure in the application WarmResethn should be used.

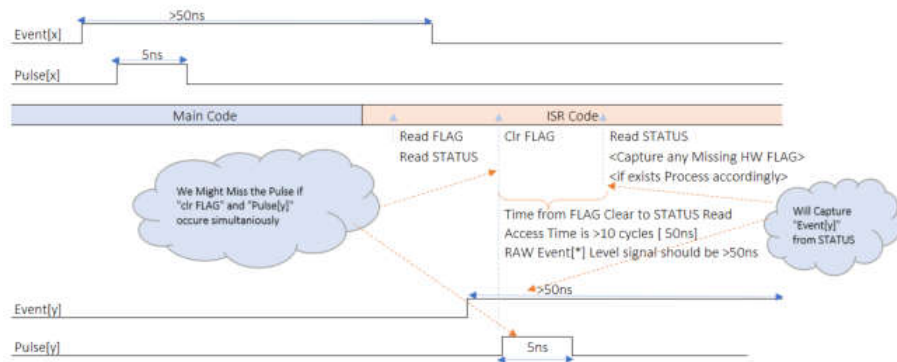
i2405 CONTROLSS: Race condition OUTPUT_XBAR and PWM_XBAR resulting in event miss

WA-1: ISR Sequence:

- Read FLAG Event[x]
- Read STATUS, All events
- Clr FLAG, Event[x]
- Read STATUS, All events
- Capture any missing HW event FLAG
- If exists, process accordingly

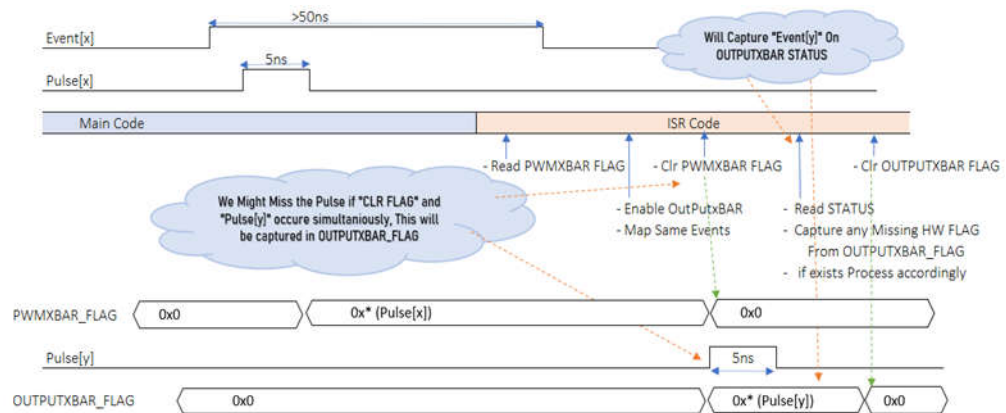
i2405 (continued) CONTROLSS: Race condition OUTPUT_XBAR and PWM_XBAR resulting in event miss

- Capture any Missing HW event FLAG

if exists Process accordingly

- Clr FLAG, Event[y] OutputXBAR

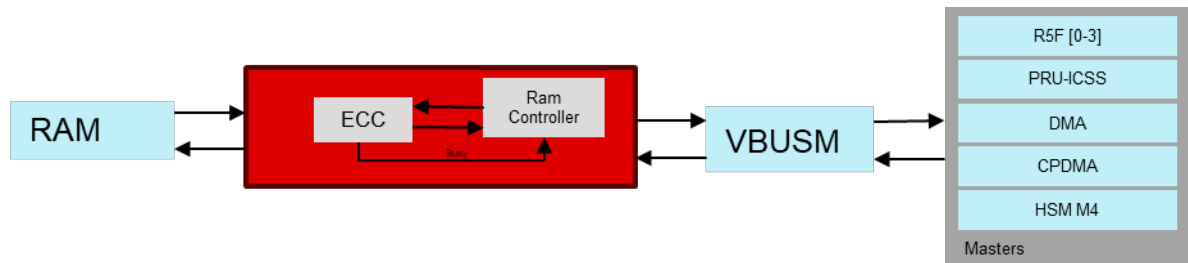
- When a single-bit error is detected during a burst read, the ECC module inserts a BUSY cycle in between.
- In this BUSY cycle, the next read from memory is halted and a corrected write back is performed to fix the error in RAM.
- The BUSY signal generated during this process is improperly handled by the Bus Protocol logic.
- Upon resuming the burst read, the data pipeline becomes misaligned.

- Incorrect data is returned to the master for reads following error correction.
- May cause program execution failures and abort exceptions.

This issue affects only L2 and MBOX RAM read operations.

The physical RAM contents remain properly corrected (no memory corruption) and write operations function normally. Below is the high level block diagram.
