Errata

F29H85x, F29P58x, and F29P32x Real-Time MCUs Silicon Errata (Silicon Revisions C, B, A, 0)

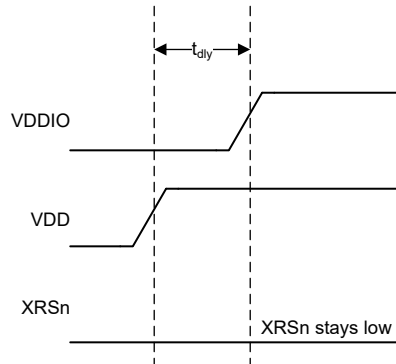
Figure 3-4. Incorrect Power-up Sequence Leading to Stuck Reset
Workaround

The device XRSn reset signal can remain in a low (reset asserted) state when the VDD supply voltage is ramped up before or simultaneously with the VDDIO supply. As a result, the device fails to boot.

Ensure the VDDIO supply is fully ramped up at least 1ms before ramping up the VDD supply voltage.
