# **AWR1843AOP Device Silicon Errata**

## **Silicon Revision 1.0**

This document describes the known exceptions to the functional and performance specifications to TI CMOS Radar Devices (AWR1843AOP).

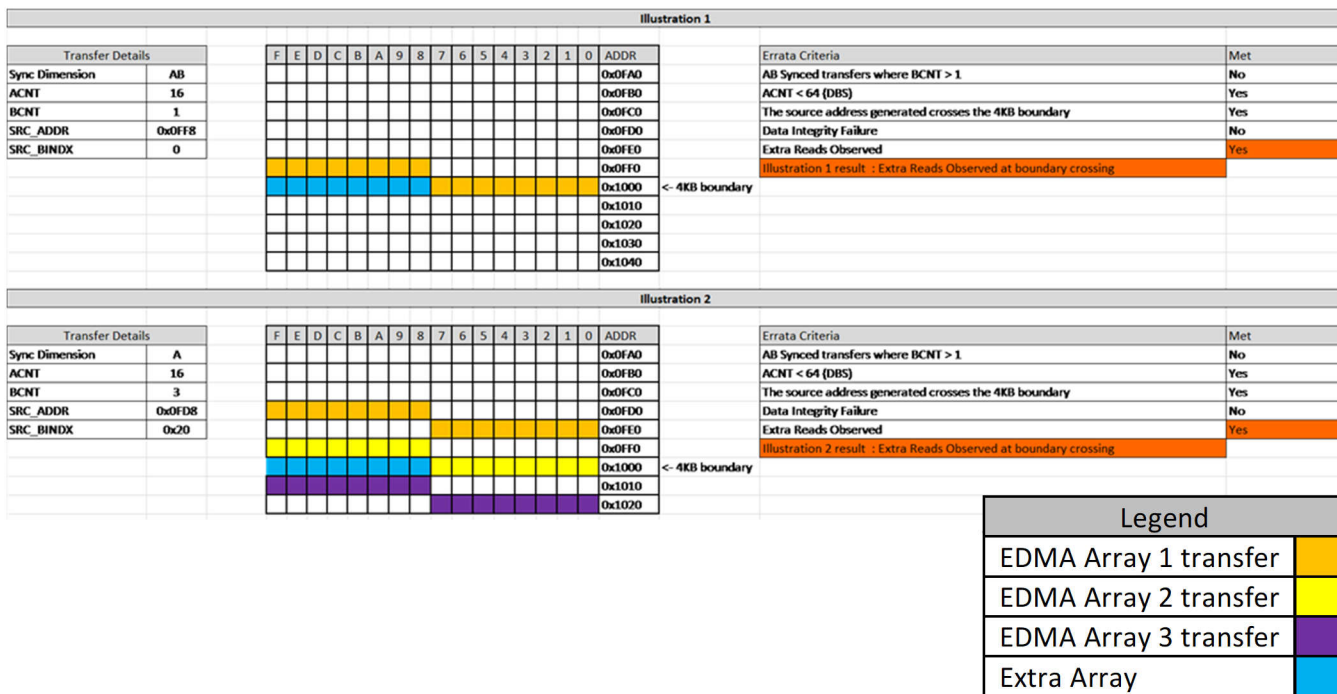
**Figure 6-1. Scenario ID #3 – Extra Reads**

For each extra read in **Scenario ID #3** for which [Condition \[1\]](#) is applicable, each index i above that satisfies the condition results in extra read from starting address SRC\_ADDR + (i + 1) \* SRCBIDX and of length equal to the distance from the start address to the boundary [that is, 0x1000 – X(i)]. Note: length < ACNT.

For **Scenario ID #3, Scenario ID #4, and Scenario ID #5**– EXTRA READS, another workaround besides avoiding the 4-KB boundary cross conditions, is to ensure that buffers involved in this kind of transfer are positioned so that extra reads stay within the physical memory boundaries. If the extra reads go to Reserved space or space blocked by the Memory Protection Unit (MPU), the TPTC generates a bus error interrupt to the processor.

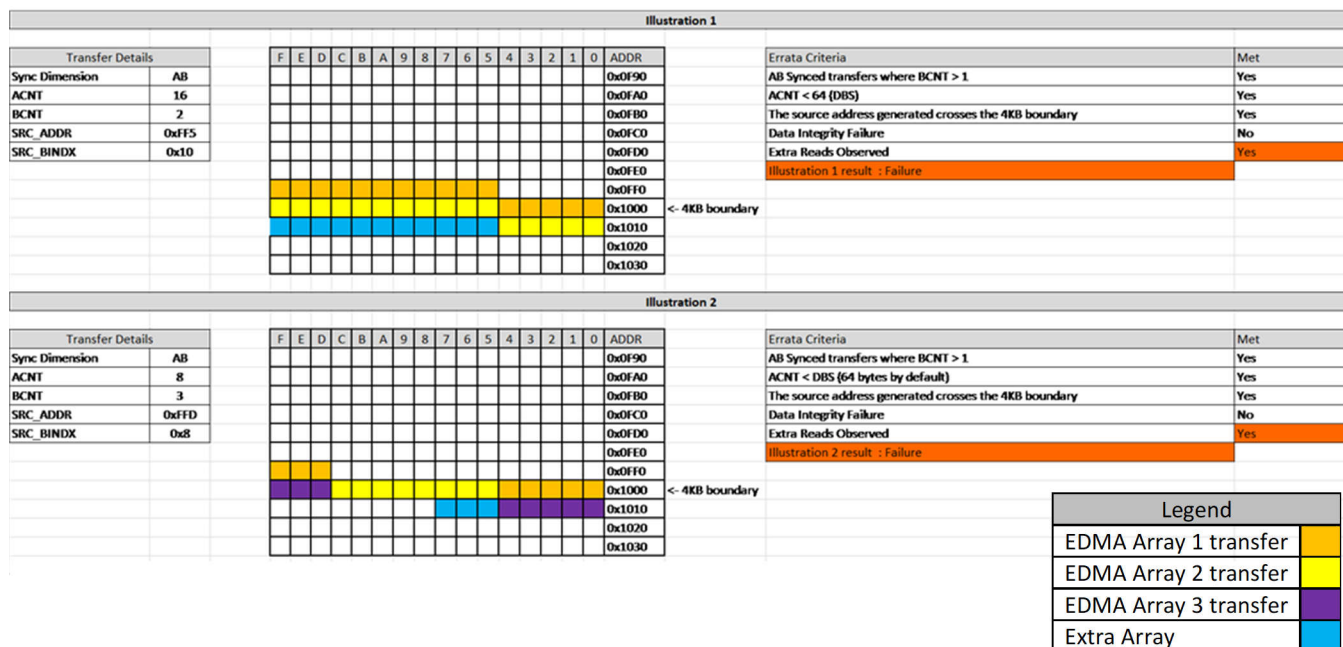
**Figure 6-2. Scenario ID #4 – Extra Reads**

For each extra read **Scenario ID #4** in for which [Condition \[1\]](#) is applicable, there is an extra read from starting address SRC + BCNT \* ACNT (=SRCBIDX) of length equal to the distance of the start address to the boundary [that is, length is 0x1000 – X(i)], where i is the index of one and only 4-KB boundary crossing condition. Note: length < ACNT.

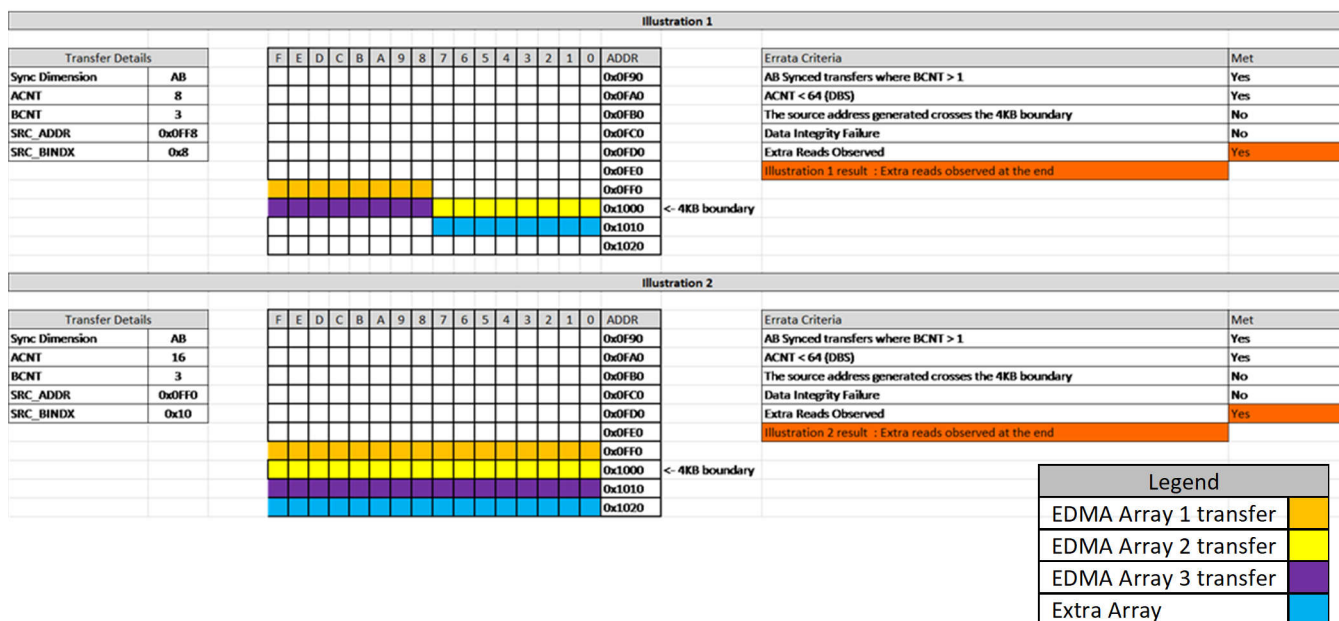
**Figure 6-3. Scenario ID #5 – Extra Reads**

For the extra read **Scenario ID #5** in for which [Condition \[2\]](#) is applicable, there is an extra read from starting address SRC + BCNT \* ACNT (=SRCBIDX) of length equal to the distance of the start address and is of length ACNT.

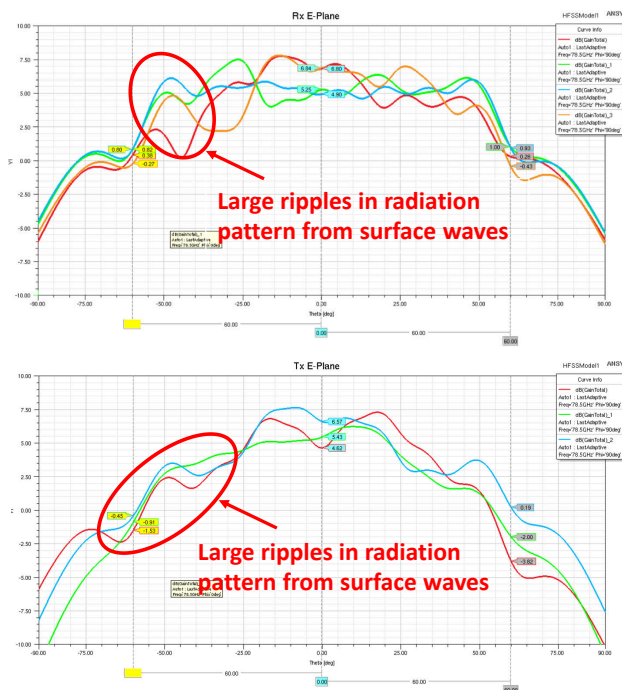
Large PCBs area around the E-plane causes surface waves that create large ripples in the elevation direction of the AoP antenna radiation pattern.
