Errata

# J721S2/TDA4VE/TDA4AL/TDA4VL/AM68A Processor Silicon Revision 1.0

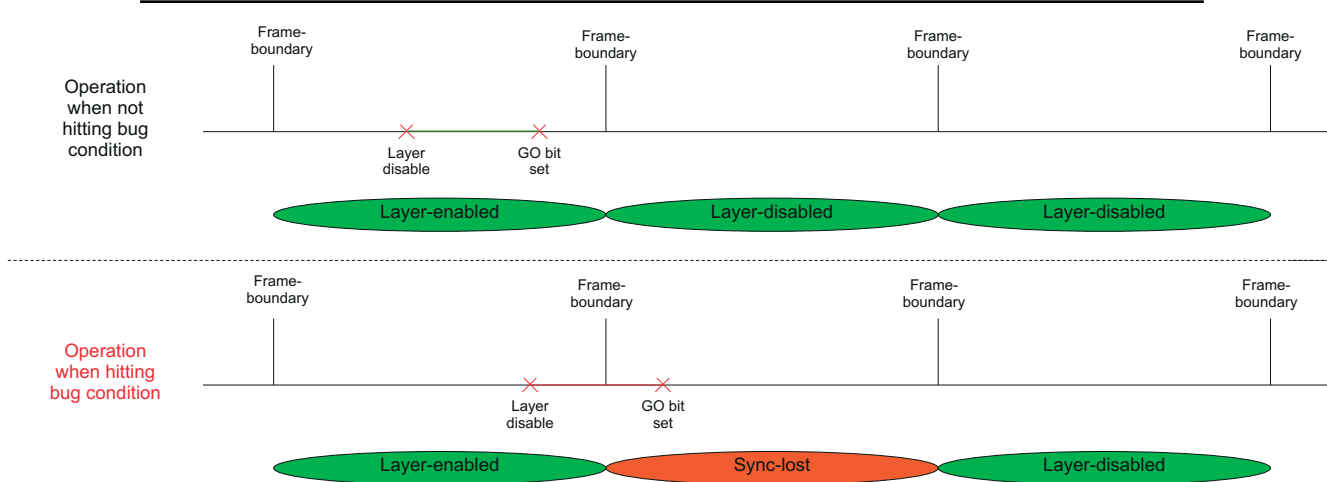
**Figure 3-1. Bug Condition**

**Details:** Disabling a layer (for example VID1) connected to an OVR (that is toggling DSS\_VID\_ATTRIBUTESx[0] ENABLE from 1 to 0) may result in synclost during the next frame. The synclost may result in a corrupted or blank frame (all pixel data sent out of DSS during the frame is 0x0). The occurrence of synclost is dependent on the timing of setting the GO bit (that is DSS\_VP\_CONTROL[5] GOBIT to 1) vis-à-vis the disabling of the layer. If the “disable layer” MMR write operation and “set GO bit” MMR write operation happens within the same frame boundary, no synclost occurs. If the operations happen across the frame boundary, then synclost occurs (for one frame). The design automatically recovers and returns to normal operation from the next frame after GO bit is set, see [Figure 3-1](#).

**i2097 (continued) DSS: Disabling a Layer Connected to Overlay May Result in Synclost During the Next Frame**

**Workaround(s):**

A sample software workaround pseudo-code is shown on [Figure 3-2](#). In this case, the regular “disable layer” MMR write operation and “set GO bit set” MMR write operation are replaced with macros which implement the software workaround.

- Replace layer disable MMR write operation with a macro which positions the layer to the non-visible area of the OVR
- Track which layers are disabled. This will be used while GO bit is set
- Replace GO bit set MMR write operation with this macro
- First, set GO Bit for the changes in “disable\_layer” macro (and any other earlier changes) to take effect
- After the first GO bit set, few idle\_cycles (10 DSS functional clock cycles) are necessary before we move to the second step
- In the second step, actually disable the layers based on the previously tracked information
- Set the GO bit for the second time for the disable of the layers to take effect

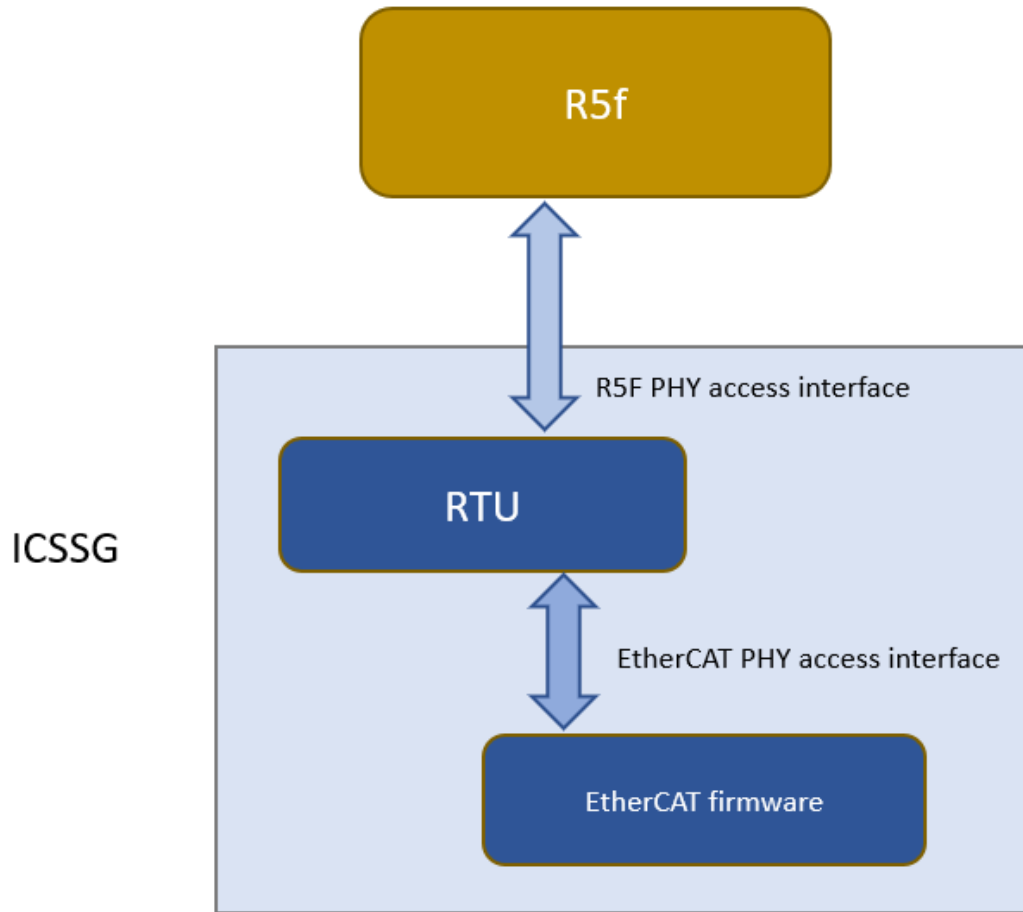
**Figure 3-4. MDIO Emulation via Manual Mode using PRU Core**

**i2329 (continued) MDIO: MDIO interface corruption (CPSW and PRU-ICSS)**

EtherCAT will continue to use PHY fast link detection via MDIO MLINK bypassing state m/c for link status (as this path is not affected by errata). This makes sure that cable redundancy related latency requirements are still met.
