OMAP4430 Multimedia Device

**Texas Instruments OMAP™
Family of Products**

Silicon Errata

Literature number: SWPZ009A

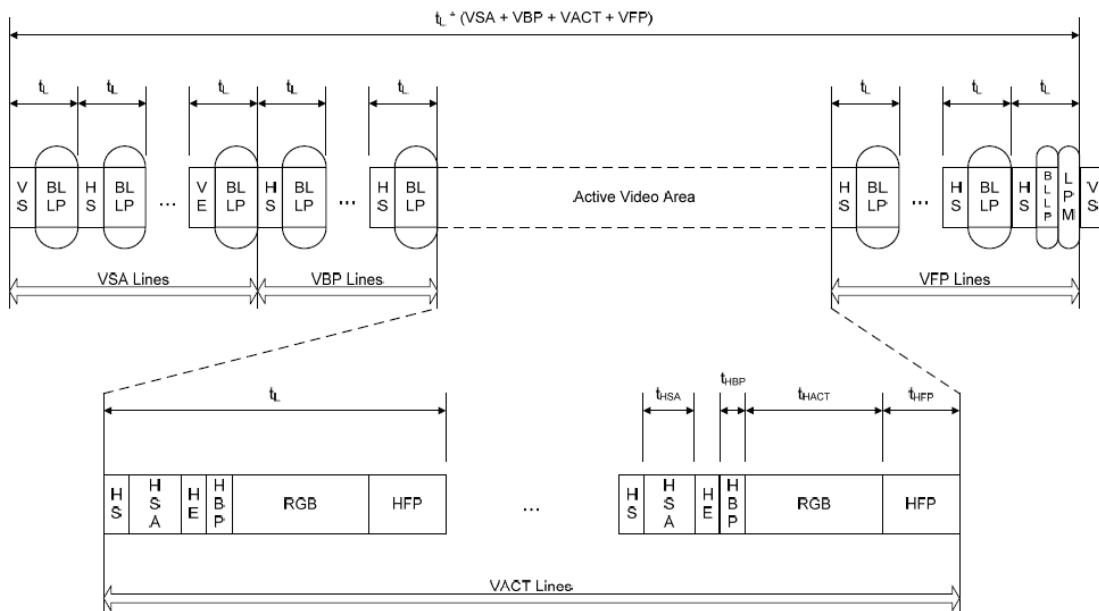
Figure 2.1. MIPI DSI 1.00 (Implemented) - Video Mode Interface Timing: Nonburst Transmission With Sync Start And End.

- The DSI protocol engine sends only HE packets (when enabled) during VACT and not during VSA, VFP, and VBP.
- The DSI protocol engine sends VE (noted as VSE in MIPI DSI ver. 1.01 specification) during VSA and not during VBP.

Figure 2.1 represents actual implementation and Figure 2.2 represents MIPI DSI ver. 1.01 specification.
