NN325-Q1 Device Erratasheet

1 Revision History

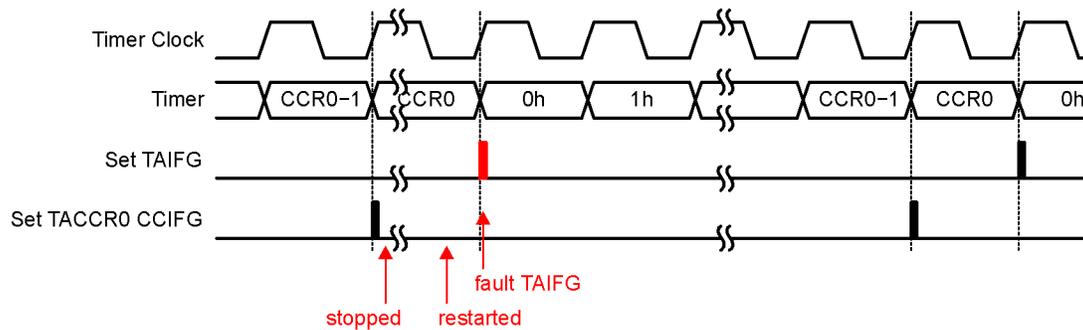
TA21	TIMER_A Module
Function	TAIFG Flag is erroneously set after Timer A restarts in Up Mode
Description	In Up Mode, the TAIFG flag should only be set when the timer counts from TACCR0 to zero. However, if the Timer A is stopped at TAR = TACCR0, then cleared (TAR=0) by setting the TACLr bit, and finally restarted in Up Mode, the next rising edge of the TACLK will erroneously set the TAIFG flag.

Workaround	None.
TAB22	TIMER_A/TIMER_B Module
Function	Timer_A/Timer_B register modification after Watchdog Timer PUC
Description	Unwanted modification of the Timer_A/Timer_B registers TACTL/TBCTL and TAIV/TBIV can occur when a PUC is generated by the Watchdog Timer(WDT) in Watchdog mode and any Timer_A/Timer_B counter register TACCRx/TBCCRx is incremented/decremented (Timer_A/Timer_B does not need to be running).
Workaround	Initialize TACTL/TBCTL register after the reset occurs using a MOV instruction (BIS/BIC may not fully initialize the register). TAIV/TBIV is automatically cleared following this initialization.
