August 2009

Clearing Module Interrupt Flags in LPW SoC Devices

By Kristoffer Flores

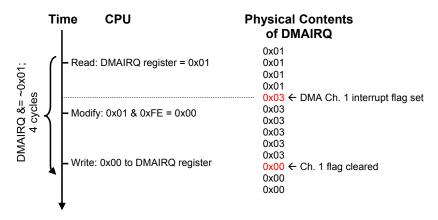
The possibility of losing interrupt flags arises because this instruction requires a read-modifywrite operation. The CPU reads the value from RegisterName, the necessary operations are performed with the read value, and the computed value is written back to RegisterName. Suppose DMAIRQ is initially 0x01 due to a channel 0 interrupt and the example DMA ISR has been called. The ISR finds the channel 0 flag in DMAIRQ and executes DMAIRQ &= ~0x01to clear the flag. In executing this instruction, the CPU first reads the value of DMAIRQ, or 0x01. A bit-wise AND is then performed between this read value and 0xFE (i.e. ~0x01), resulting in 0x00. Finally, the CPU writes 0x00 back to the DMAIRQ register.

Suppose another channel, DMA channel 1, reaches its transfer count in the time between the read and write in the RMW operation above. DMAIF is reasserted and the channel 1 interrupt bit in DMAIRQ is asserted by hardware so that the physical value of DMAIRQ is 0x03. However, the CPU is performing operations on the previously read value of DMAIRQ, 0x01. The CPU calculates 0×01 & $0 \times FE = 0 \times 00$, and writes 0x00 to DMAIRQ, clearing the interrupt flag for DMA channel 1. The ISR continues and completes with no apparent errors. Figure 1 illustrates this sequence by showing the operations of the CPU and the physical contents of the register.

Figure 1. Timing diagram showing a missed interrupt flag on DMA channel 1 due to the instruction, DMAIRQ &= ~0x01, to clear the DMA channel 0 interrupt flag.

Continuing the above scenario, the CPU calls the DMA ISR again (since DMAIF = 1) immediately after the previous ISR execution completes. This time, DMAIRQ is 0x00 and both if-statements fail. DMA channel 1 is not rearmed and will not process new transfers when triggered. If channel 1 is not rearmed anywhere else in the program code, the channel remains idle until the DMA initialization code (which arms the channels) executes again due to a system reset or fresh power-up. In single transfer modes, a DMA channel must be rearmed after each completed transfer count before it can be triggered again to execute other

The solution to prevent missing interrupts takes advantage of the Write-0 bit behavior. For the DMA example, instead of using DMAIRQ &= $\sim 0 \times 01$ and DMAIRQ &= $\sim 0 \times 02$, the ISR should use DMAIRQ = $\sim 0 \times 01$ and DMAIRQ = $\sim 0 \times 02$, respectively. These instructions will clear the desired bit with a 0 and write 1s to the other bits to preserve the physical register values. In a general form, for a module interrupt flag register with all Write-0 bits, replace RegisterName &= \sim FlagBit with RegisterName = \sim FlagBit.
