# Errata

## J721S2/TDA4VE/TDA4AL/TDA4VL/AM68A Processor Silicon Revision 1.0

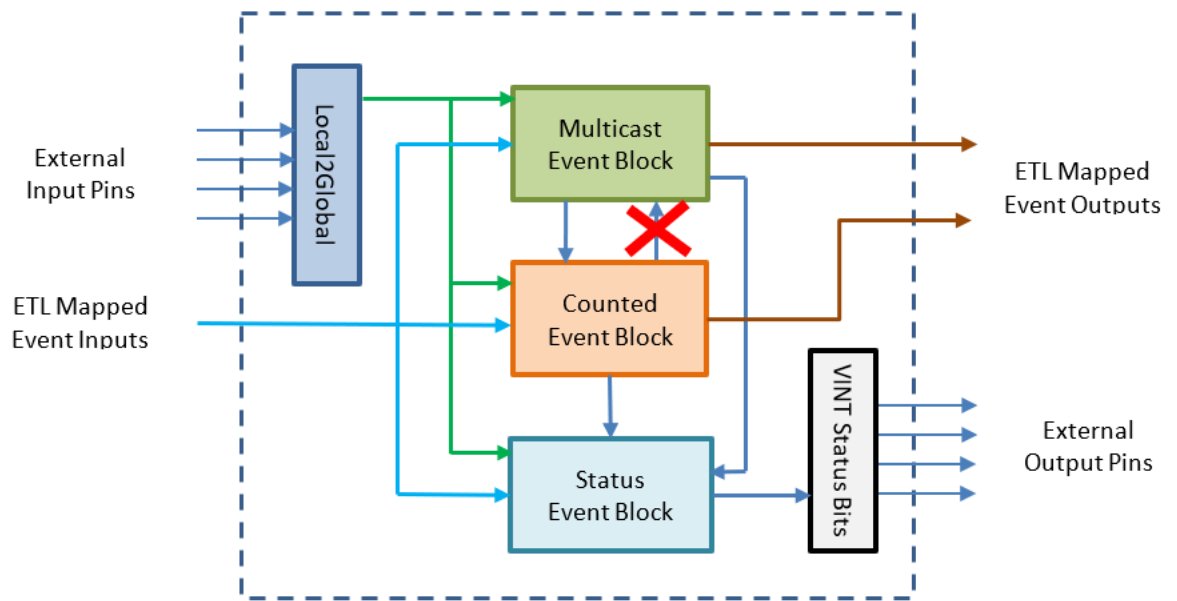
**Figure 3-3. Interrupt Aggregator Version 1.0**

An issue was found after design that could cause the IA to deadlock. The issue occurs when event “loops” occur between these three processing blocks. It is possible to create a situation where a processing block can not output an event because the path is blocked, and since it can not output an event, it can not take any new input events. This inability to take input events prevents the output path from being able to unwind, and thus both paths remain blocked.

**Workaround(s):**      [Figure 3-3](#) shows the conceptual block diagram of IA 1.0. Potential loops are avoided by adopting the policy of not allowing the counted event block to send events to the multicast block. This method was chosen because it is more common to split an event first, and then count one while sending the other elsewhere. With this path blocked by convention, it is not possible for a single event to visit any block more than once and thus not possible for paths to become blocked so long as the outputs remain unblocked.

By following the conventions outlined here, the system is safe from looping hazards that can create a deadlock scenario.
