Appropriate CCS Configurations for the UCD3138 Family of Digital Power Controllers

ABSTRACT

The UCD3138, a family of TI's high-performance digital power controllers, requires appropriate CCS configurations for operation. When the user renames a UCD3138 project, upgrades CCS, or uses another computer, unexpected issues may occur even with a previously working Firmware project. These issues are generally caused by inappropriate CCS configurations. This application note lists these issues and provides solutions.

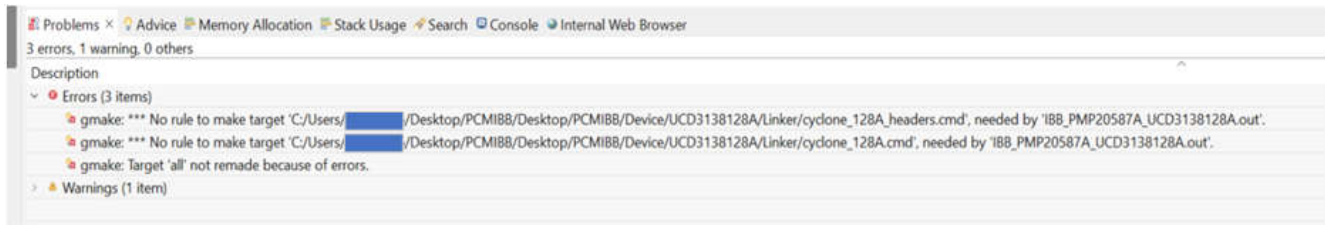
Figure 2-1. "No rule to make target" Error

Typically, users do not use the TI EVM code project name directly as their CCS project name. They generally require a custom project name. However, they may encounter some build errors when renaming CCS projects. [Figure 2-1](#) shows common error messages.

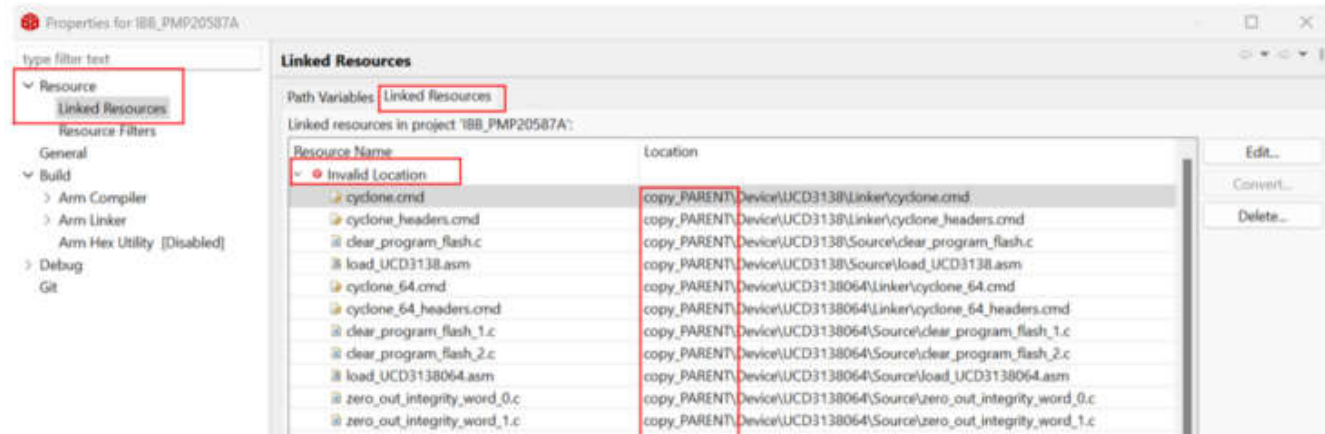
Figure 2-2. Invalid Location for Linked Resources

Renaming the project causes the *Linked Resources* to automatically change the default path to "copy_PARENT". However, this is a path that does not exist on the user's local computer. An *Invalid Location* error appears under *Project Properties* -> *Resource* -> *Linked Resources* -> *Linked Resources*, as shown in [Figure 2-2](#).

To resolve this error, users need to replace all "copy_PARENT" with "PROJECT_LOC\..\!". A correct path setting is shown in [Figure 2-3](#).

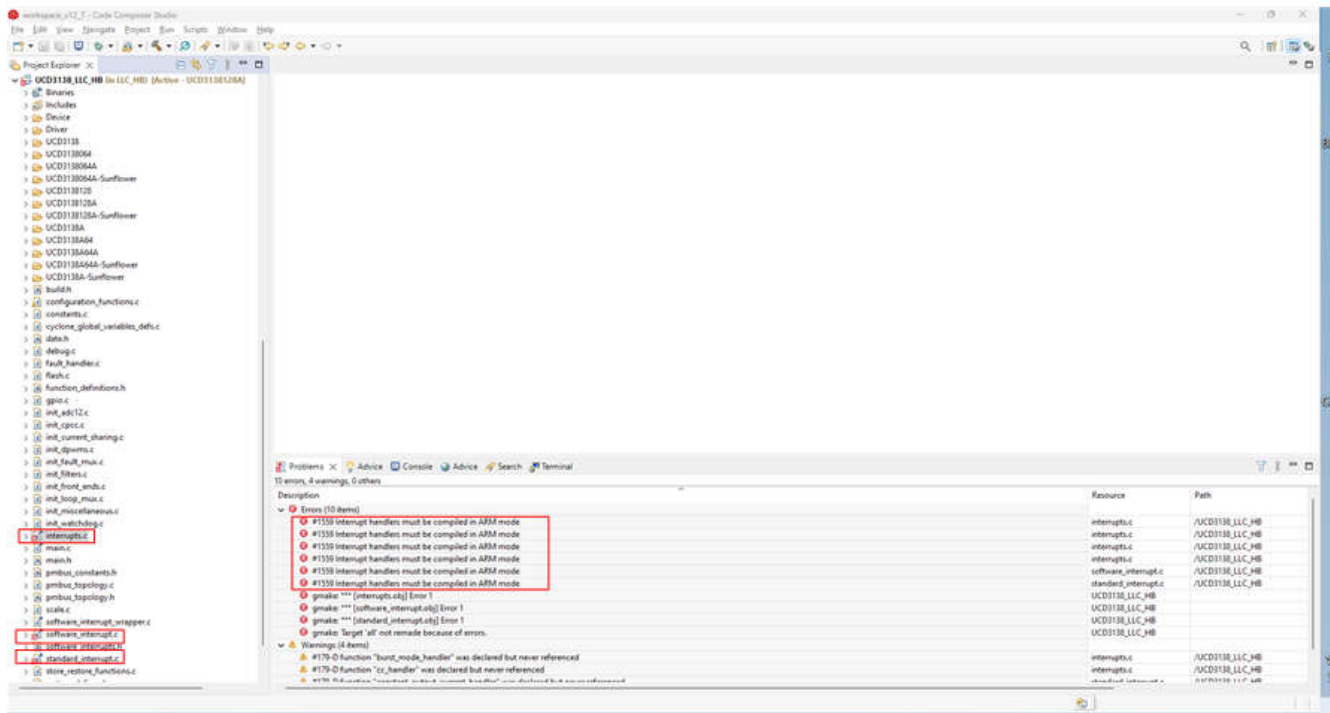
Figure 2-4. Interrupt Handlers Must Be Compiled in ARM Mode

A project that was previously built successfully may experience build failures caused by upgrading CCS or setting up a new computer. Common error prompts include "#1559: Interrupt handlers must be compiled in ARM mode", which refers to files "standard_interrupt.c", "software_interrupt.c", and "interrupts.c", as shown in Figure 2-4. The root cause of this error is that interrupt service functions must be built in ARM mode instead of Thumb mode. During CCS upgrading, the original configuration for the ARM mode may not be preserved and is automatically changed to the configuration for the Thumb mode, resulting in this issue (Note that .C files are usually built in Thumb mode to reduce code size).

1. Configure files "standard_interrupt.c", "software_interrupt.c", and "interrupts.c" to be built in ARM mode. For example, to configure the entire "software_interrupt.c" file to be built in ARM mode, as shown in Figure 2-5, follow the steps below to complete the configuration. Open the *Project Explorer* pane, right-click "standard_interrupt.c", go to *Properties -> Build -> ARM Compiler -> Processor Options*, and select "32".

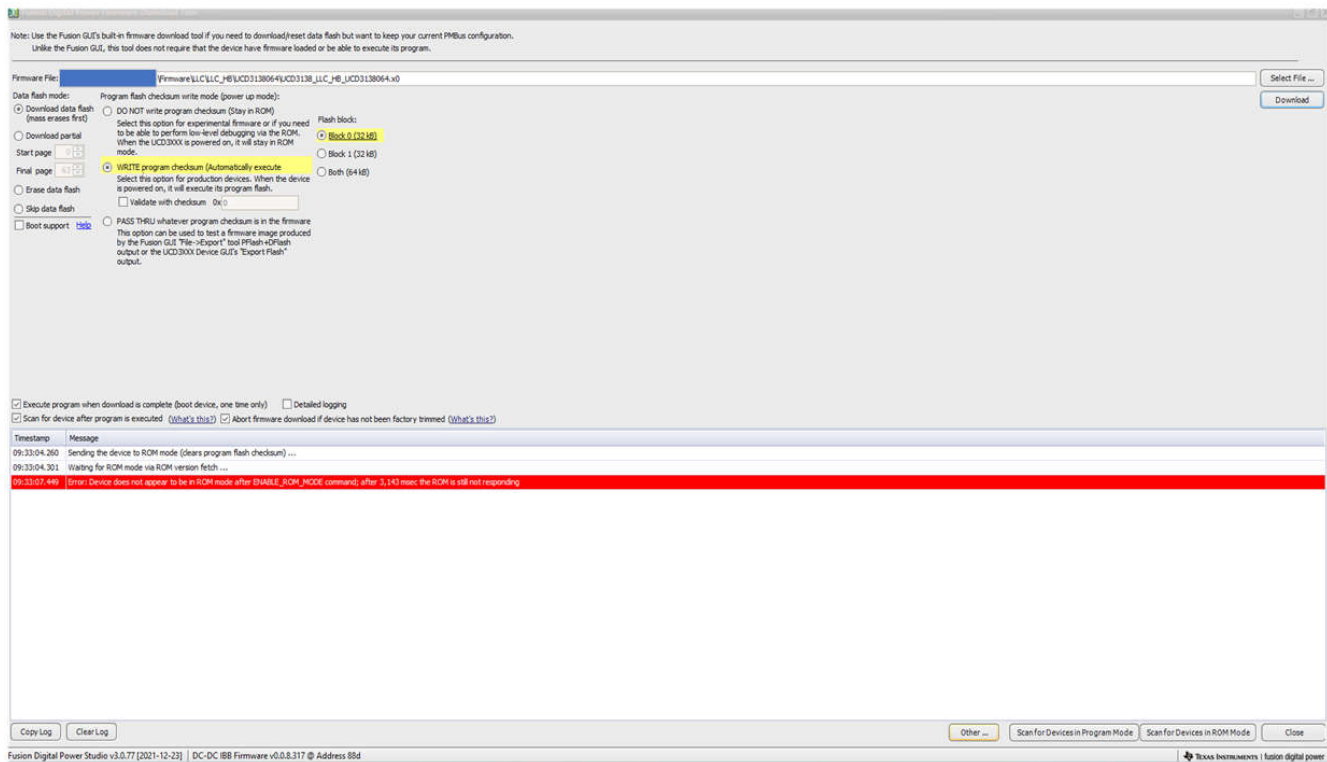
Figure 2-6. Device Lockup

Similarly, users may encounter device lockup after upgrading CCS, which prevents the image from being re-flashed. An error prompt, "Device does not appear to be in ROM mode after ENABLE_ROM_command", is shown in [Figure 2-6](#).

- The first one is that the user is using an incompatible version of the compiler. The EVM codes for UCD are all developed using compiler versions TI V5.2.2-V5.2.5. Some EVM codes do not work well with other compiler versions, such as V5.2.9. If the user encounters a chip lockup, first check whether a compatible compiler version is being used. If not, a compatible compiler must be installed. The installation steps are as follows:

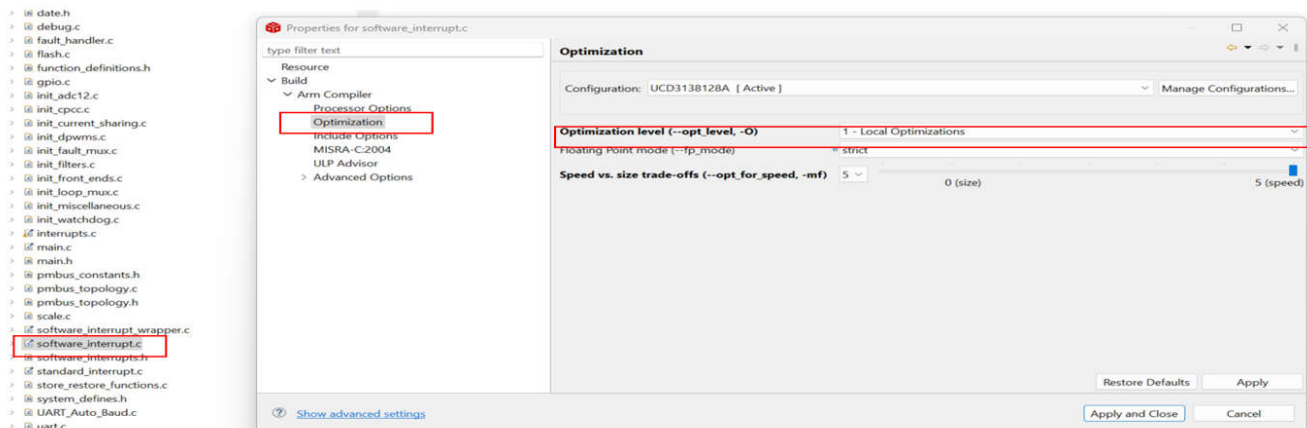
Figure 2-9. Select 1-Local Optimizations

- Another potential cause is that the file "software_interrupt.c" is configured to a *code optimization level* that is too aggressive (such as "2-Global Optimizations"), causing the *checksum* to not be erased successfully. At the "2-Global Optimizations" level, it is true that some UCD3138 devices can successfully erase the checksum. However, some other UCD3138 devices fail to erase their *checksum*. To resolve this issue, the file "software_interrupt.c" must be configured to a lower *optimization level*, such as "1-Local Optimizations". The configuration steps are shown in Figure 2-9. Open the *Project Explorer* pane, right-click "software_interrupt.c", go to *Properties -> Build -> ARM Compiler -> Optimization -> 1-Local Optimizations*.

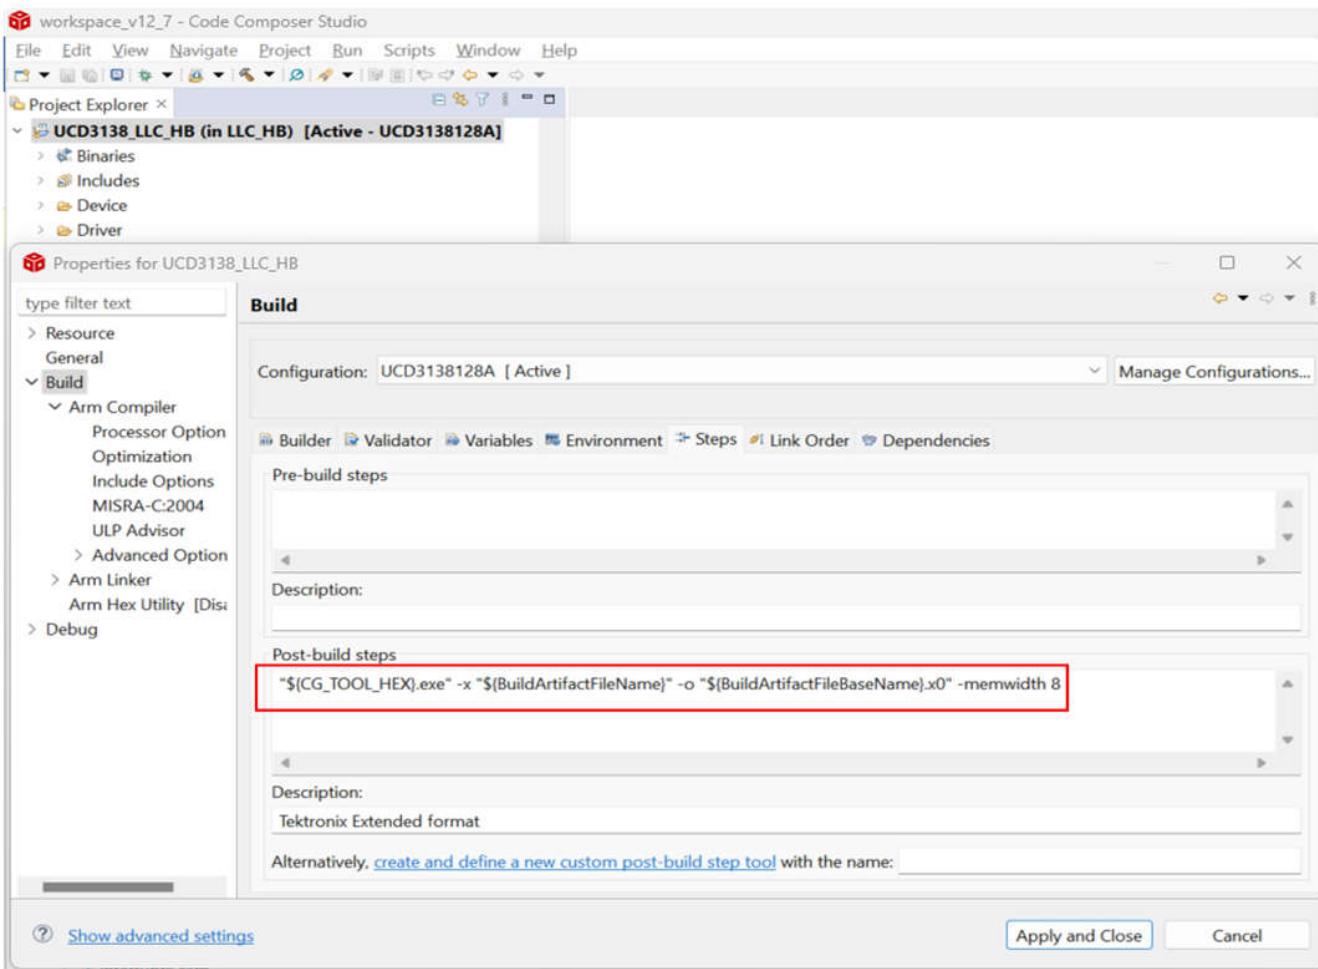
Figure 2-10. Post-build Step for Converting the .out File to a .x0 File

The image downloaded to a UCD device is typically in .x0 format. However, sometimes users cannot find the .x0 file after a successful build. Instead, a .out file is typically generated directly after the build is complete. To generate a .x0 file, a post-build command line, `"${CG_TOOL_HEX}.exe" -x "${BuildArtifactFileName}" -o "${BuildArtifactFileName}.x0" -memwidth 8`, should be executed. As shown in Figure 2-10, check whether this command line is configured correctly.
