# **66AK2G1x Multicore DSP+Arm® KeyStone II System-on-Chip (SoC) Silicon Revision 1.0**

This document describes the known exceptions to the functional specifications (advisories). This document may also contain usage notes. Usage notes describe situations where the device's behavior may not match presumed or documented behavior. This may include behaviors that affect device performance or functional correctness.

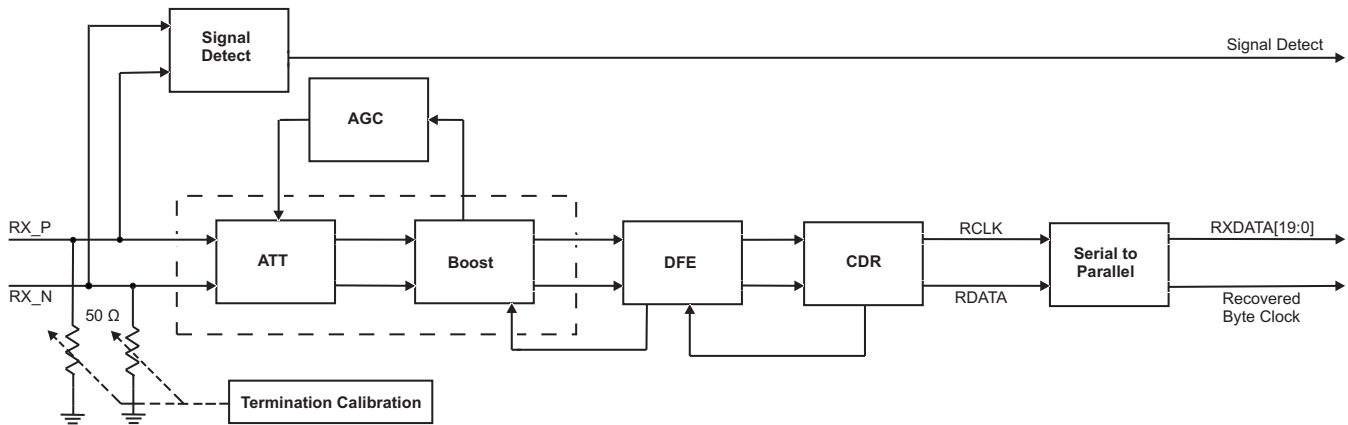
**Figure 2. RX Path Block Diagram**

The SerDes on PCIe will not automatically adapt its RX equalization when provided with certain data encodings common to that peripheral's electrical standard.

The TI SerDes contains an adaptation algorithm that allows the RX equalization blocks to adapt their parameters to the SerDes data channel. The adaptation algorithm sets the optimal values for the ATT, BOOST, and DFE blocks in order to equalize the signal, maximize margin, and minimize channel distortion. For higher data rates (that is 5Gbps and greater), the high frequency gain provided by the BOOST block is generally considered necessary to compensate for the low-pass characteristics of data channels and widen the data eye.

The SerDes BOOST block was designed to require a specific set of patterns in order to best adapt its parameters to the channel. If these patterns are not found, the BOOST adaptation algorithm will not update the internal block settings and/or may incorrectly update these settings. The required data pattern is a series of six 0's followed by a 101 pattern. This pattern must occur numerous times on both odd and even bit alignments. This data pattern is not present in the 8b/10b coded symbols that are sent over many of the high speed peripheral links.

The data pattern is present in longer length PRBS patterns such as PRBS-23, and PRBS-31 used by the SerDes internal BIST hardware used during BER testing. The data pattern that is required is not present in the symbols used in PCIe SerDes interfaces during data transport.

If the BOOST has not been properly adapted for the received signal, then there is a chance that the SerDes will be unable to recover the RX data or the error rate may be higher than expected.

The recommended workaround is to not use the RX equalization auto-adaptation mechanism with the impacted interfaces at higher data rates. As an alternative, a user can hardcode the optimal ATT and BOOST values for their channel. These optimal ATT and BOOST values must be determined by the user through one of two options:

- Perform BER test with PRBS sequence and sweep across all values of ATT/BOOST while using a fixed set of TX parameters that have already been optimized. Use optimal ATT and BOOST value permutation that has the most margin. This is the value permutation that is both error-free and "farthest" from permutations with errors.
  - The SerDes DIAG tests can be found under <TI\_PDK\_INSTALL\_DIR>\packages\ti\diag\serdes\_diag in the latest CSL/PDK release and can be configured to perform this test.
- Perform a test where a PRBS data pattern is presented to the RX and the ATT/BOOST are allowed to auto-adapt. This method can also be used to identify the optimal ATT and BOOST value permutation that has the most margin.

The optimal ATT and BOOST values found by one of the two above methods can be hardcoded into the SerDes upon initialization.
