Errata AM263Px Sitara™ Microcontroller Silicon Revision 1.0

ABSTRACT

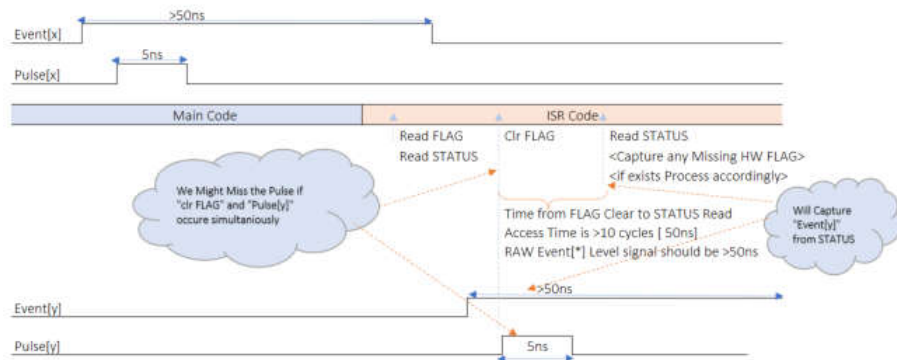
By default, level events (width >50ns) will be captured in “STATUS” Register, while performing “Clr Flag”, if any new event from hardware is asserted at the same time, it will be missed in FLAG Register, However, STATUS register does capture such events missed in FLAG register. After completing “Clr FLAG”, reading the “STATUS” register allows to capture/process any missed event based on “STATUS” read.

WA-1: ISR Sequence:

- Read FLAG Event[x]
- Read STATUS, All events
- Clr FLAG, Event[x]
- Read STATUS, All events
- Capture any missing HW event FLAG
- If exists, process accordingly

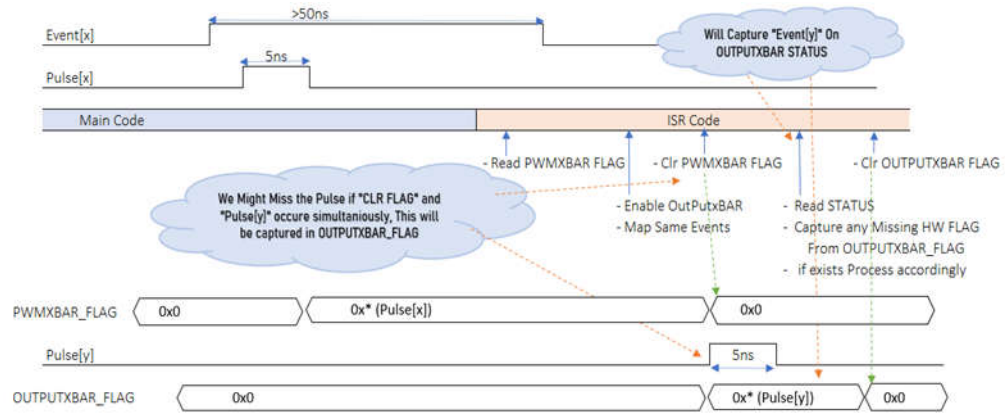
Enable OUTPUTXBAR with the same events in the ISR and then “Clr PWMXBAR FLAG”.

Any missed Hardware event during the same window will be captured in OUTPUTXBAR FLAG”. Read the OUTPUTXBAR FLAG and process accordingly

“Clr OUTPUTXBAR FLAG” followed by disable of OUTPUTXBAR in the ISR.

WA-2: ISR Sequence:

- Read FLAG Event[x]
- Read STATUS, All events
- Enable OutPutxBAR
- Map Same Events
- Clr FLAG, Event[x] PWMXBAR
- Read STATUS
- Capture any Missing HW event FLAG from OUTPUTXBAR_FLAG
- if exists Process accordingly
