## Errata

# TMS320F280x, TMS320C280x, TMS320F2801x DSPs Silicon revisions C, B, A, 0

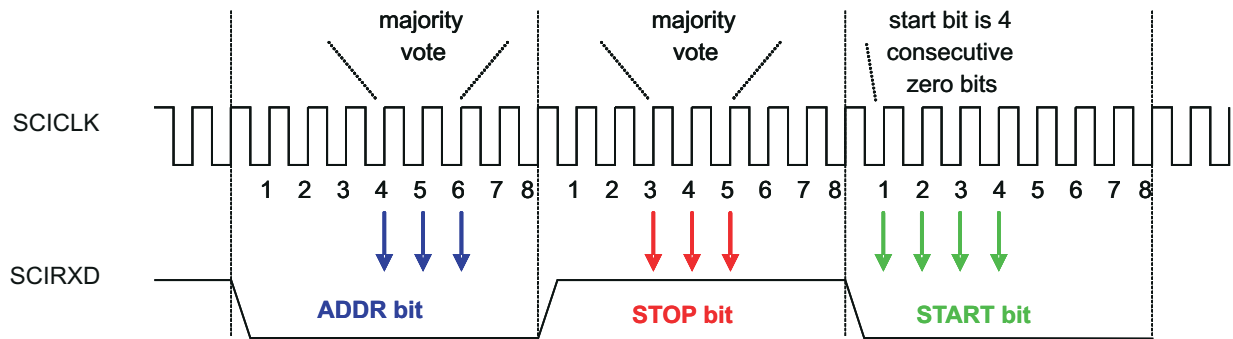
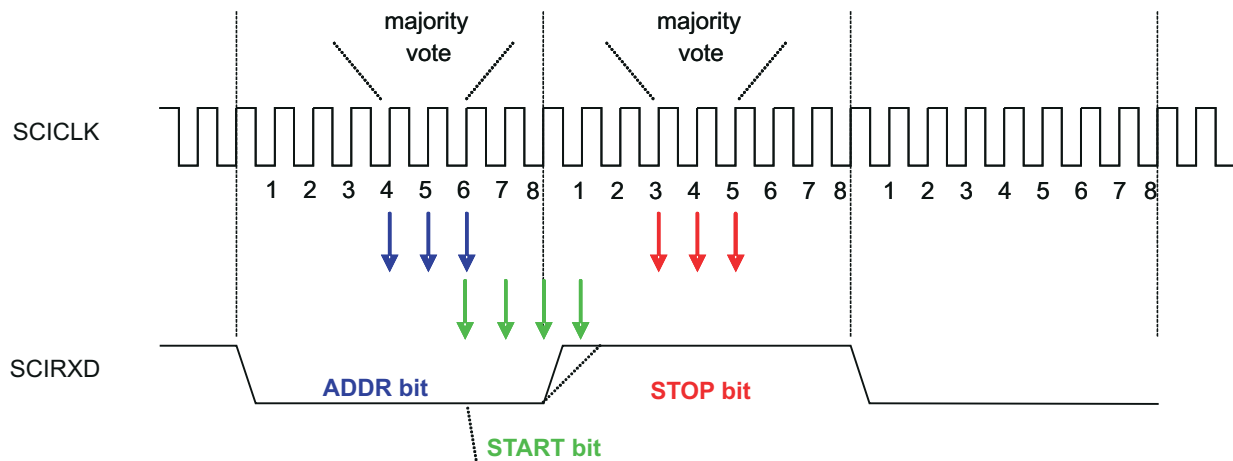
**Figure 5-1. Difference Between Expected and Erroneous Operation of START Bit**

SCI does not look for STOP bit after the ADDR bit. Instead, SCI starts looking for the start bit beginning on sub-sample 6 of the ADDR bit. Slow rise-time from ADDR to STOP bit can cause the false START bit to occur since the 4th sub-sample for the start bit may be sensed low.

Program the baud rate of the SCI to be slightly slower than the actual. This will cause the 4th sub-sample of the false START bit to be delayed in time, and therefore occur more towards the middle of the STOP bit (away from the signal transition region). The amount of baud slowing needed depends on the rise-time of the signal in the system. Alternatively, IDLE mode of the SCI module may be used, if applicable.
