ABSTRACT

This document describes the known exceptions to the functional specifications (advisories). This document may also contain usage notes. Usage notes describe situations where the device's behavior may not match presumed or documented behavior. This may include behaviors that affect device performance or functional correctness.

1 Usage Notes and Advisories Matrices

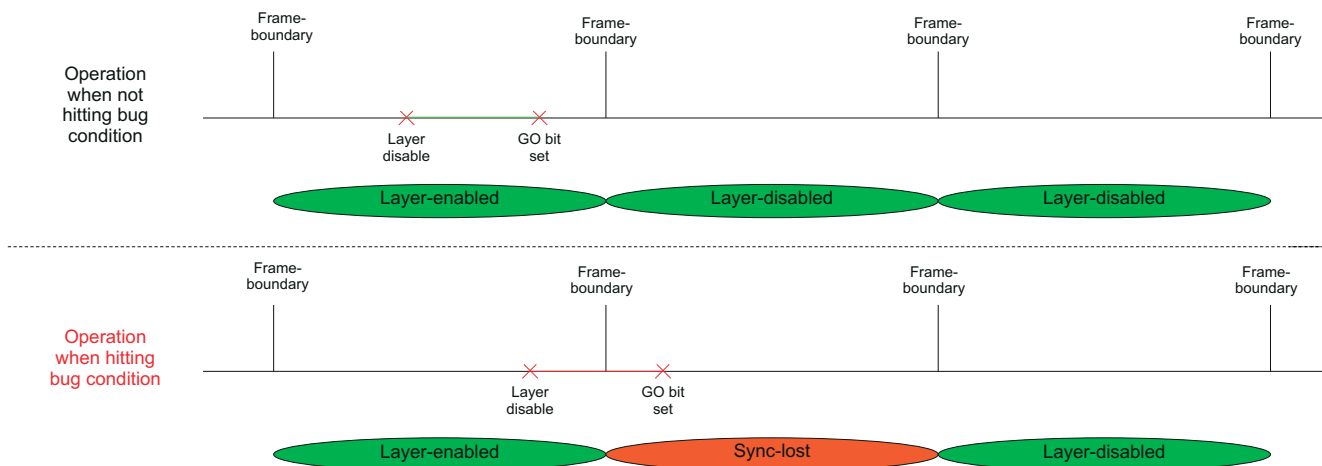
Figure 2-1. Bug Condition

DSS: Disabling a Layer Connected to Overlay May Result in Synclost During the Next Frame

Disabling a layer (for example VID1) connected to an OVR (that is toggling DSS_VID_ATTRIBUTESx[0] ENABLE from 1 to 0) may result in synclost during the next frame. The synclost may result in a corrupted or blank frame (all pixel data sent out of DSS during the frame is 0x0). The occurrence of synclost is dependent on the timing of setting the GO bit (that is DSS_VP_CONTROL[5] GOBIT to 1) vis-à-vis the disabling of the layer. If the “disable layer” MMR write operation and “set GO bit” MMR write operation happens within the same frame boundary, no synclost occurs. If the operations happen across the frame boundary, then synclost occurs (for one frame). The design automatically recovers and returns to normal operation from the next frame after GO bit is set, see [Figure 2-1](#).

A simple software workaround exists. In the workaround, prior to disabling a layer on the OVR, it is moved to the “non-visible” area of the OVR (for example: DSS_OVR_ATTRIBUTES_x[17-6] POSX = max_value_of_posx or DSS_OVR_ATTRIBUTES_x[30-19] POSY = max_value_of_posy). This avoids the synclost when the layer is disabled.

A sample software workaround pseudo-code is shown on [Figure 2-2](#). In this case, the regular “disable layer” MMR write operation and “set GO bit set” MMR write operation are replaced with macros which implement the software workaround.
