TDA2Ex SoC for Advanced Driver Assistance Systems (ADAS) 23mm (ABC) Package (SR2.0, SR1.0) 17mm (CBD) Package (SR2.1, SR2.0)

Errata

Literature Number: SPRZ428F
NOVEMBER 2014 – REVISED NOVEMBER 2026

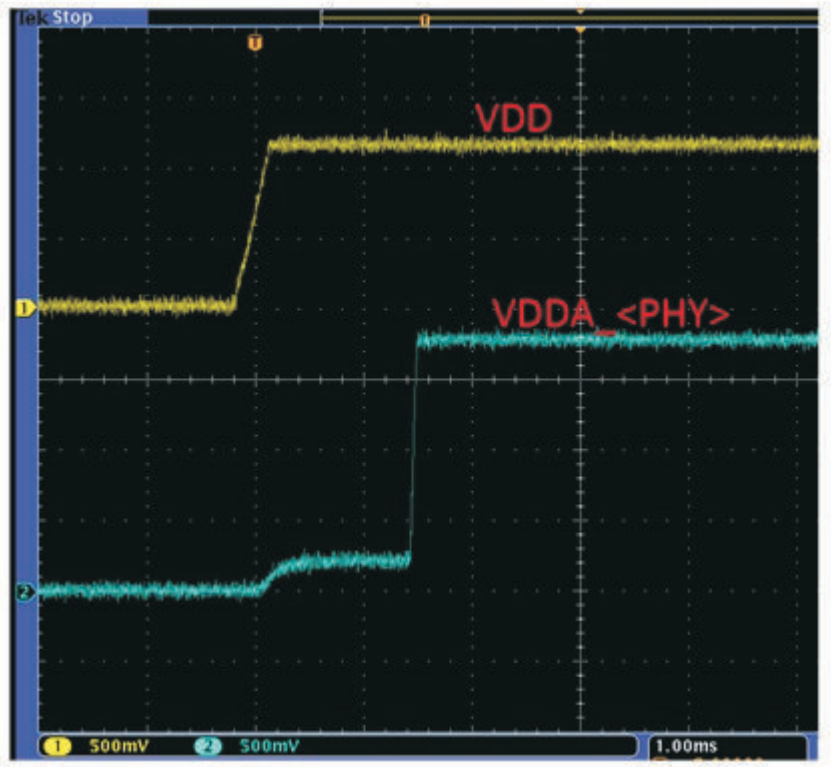
Figure 4-2. Leakage Voltage

The device-specific Data Manual requires Core AVS rail (VDD) to power up before the 1.8 V high speed analog PHY domain(s). When this sequence is followed, the high speed analog PHY domain will have a small step-up to a voltage plateau (< 0.5 V) that aligns to the beginning of the VDD ramp-up, and is maintained until the ramp-up of high speed analog PHY rail, as shown in Figure 4-2. Note the leakage value will differ from system to system, but will be less than 500 mV. The leakage voltage in the provided capture is approximately 250 mV.

A similar condition exist during supply power down sequence. The high speed analog PHY domain(s) are required to be powered down prior to Core AVS rail (VDD), and may cause a small plateau to exist until Core AVS rail (VDD) is ramped down.

The root cause of the voltage plateau during power-up/down sequencing is related to the parasitic diodes in logic blocks which have multiple power sources. This leakage path is not a reliability concern for this device.

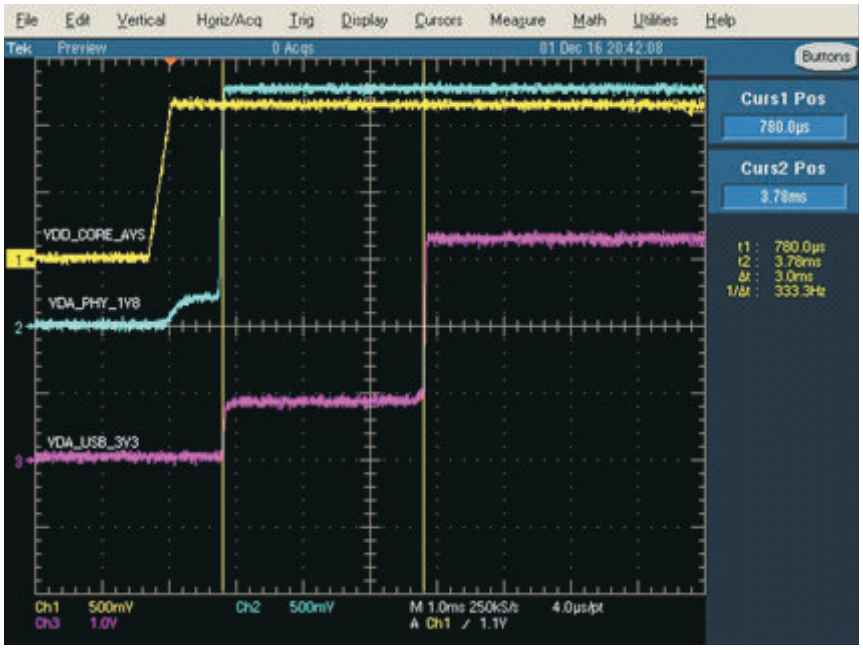
Figure 4-3. Original Power-Up Sequence

An unintended leakage current path between VDDA_PCIE (1.8 V) and VDDA33_USB1 (3.3 V) due to ESD protection diode connection across the signal to I/O supply pads exists. This path can allow current to flow from VDDA_PCIE to VDDA33V_USB1. The current flows whenever the voltage level on VDDA_PCIE exceeds VDDA33V_USB by more than a diode drop during certain power-up and power-down sequences.

This leakage current causes the un-energized VDDA33V_USB1 to rise to a ~1 V plateau (see Figure 4-3) due to the power resource's "off impedance" seen between the VDDA33V_USB1 power rail to ground. When the minimum "off impedance" is >= 100 Ω, the SoC leakage current is small and sustainable with no SoC reliability impacts.

Note: Figure 4-3 shows in VDA_PHY_1V8 rail a plateau approximately 250 mV documented in i931, VDD to VDDA_"PHY" Current Path.

TI recommended Power Delivery Networks (PDNs) could have multiple different PMIC LDO power resources connected to the VDDA33V_USB1 rail. The LP8733/32 PMICs have a minimum OFF resistance equal to 150 Ω so a PDN using these PMICs would not exceed safe leakage current level and could continue to use the original SoC power sequences. However, the TPS65917/919 PMICs have a minimum OFF resistance equal to 30 Ω and would exceed the safe leakage current limit. As a result, any PDN using TPS65917/919 PMICs must implement the revised power sequencing as shown in DM version D or later. The specific sequence changes are:

The following PMIC OTP IDs have been aligned to the revised power sequencing to avoid any leakage current:
