AM572x Sitara™ Processors Silicon Revisions 1.1, 2.0

Errata

Literature Number: SPRZ429O
JULY 2014 – REVISED OCTOBER 2026

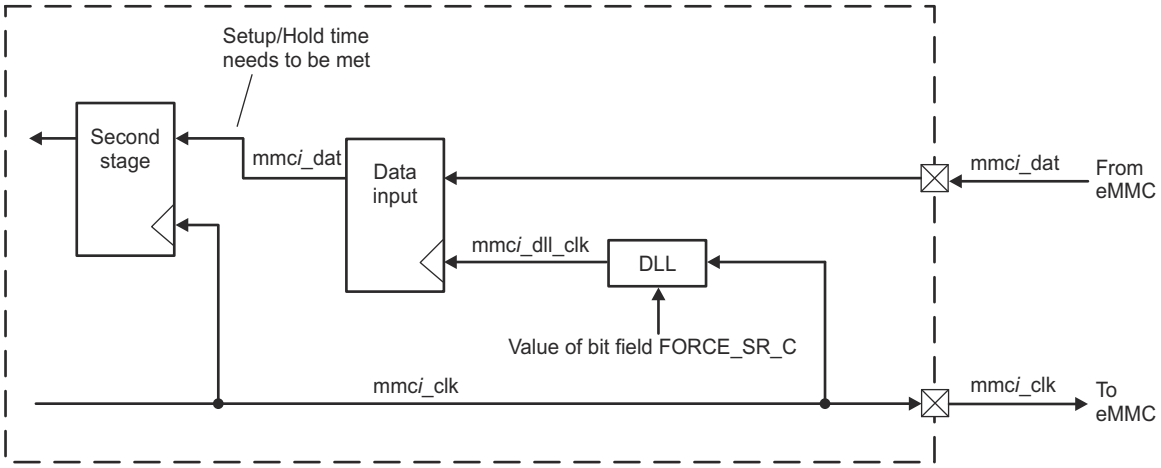
Figure 2-2. Simplified SoC 192-MHz Mode DLL Block Diagram

Internal to the MMC module, a second stage latch is used to recapture data captured by DLL delayed CLK, MMC_DLL_CLK. The second stage latch captures with the original transmitting clock, MMC_CLK.

MMC_DLL_CLK and MMC_CLK both run at the same clock frequency. This results in a narrow range of tuning ratio elements, where the delayed MMC_DLL_CLK comes in phase with MMC_CLK. If the clocks are in phase, the data captured by the first clock violates the setup and hold time requirements needed for the second stage latch, resulting in incorrectly read data. This is known as tuning re-timing errors.

A DLL tuning algorithm has been implemented that can avoid the tuning re-timing errors. More details on this can be found in App Note SPRACA9. The following notes summarize the updated algorithm:

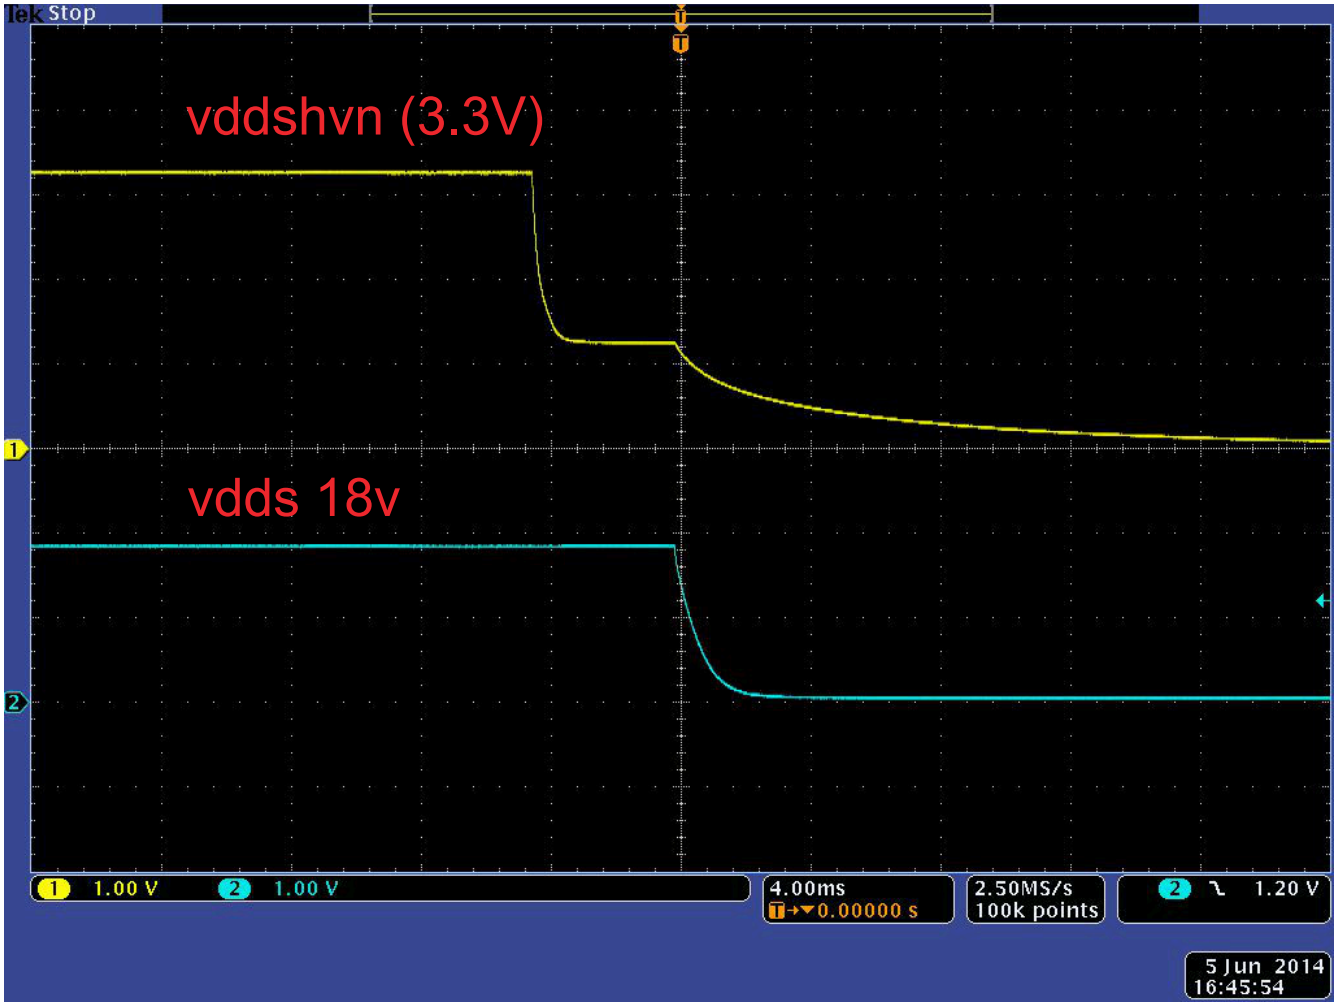
Figure 4-1. PAB_RevA

The Data Manual allows the vddshvn rail (in either 3.3V or 1.8V mode) to power down at the same time or before the vdds18v rail. When the vddshvn rail is powered down before the vdds18v rail, the vddshvn rail stays at Plateau Level (<1.5V) until the vdds18v rail is disabled, as shown in the waveform below.

A subset of the SOC's LVCMOS IOs (refer to DM for details) have a pull-up resistor that is active by default, including during reset and power-down. The SOC's IOs that have internal or external pull-ups will stay at Plateau Level (<1.5V) during the power-down. If other ICs on the board that are interfaced to the SOC's LVCMOS signals use a separate supply then it's possible that the other IC's signals can be pulled to the Plateau Level while its power supply is off.

The root cause of the plateau is related to the LVCMOS IO buffer Dual Voltage detection circuitry. The LVCMOS Dual Voltage IO includes voltage comparator circuitry to determine

In general, TI recommends using the same supply source for connected components. E.g., a single LDO should drive vddshvn and the related 3.3V external components.

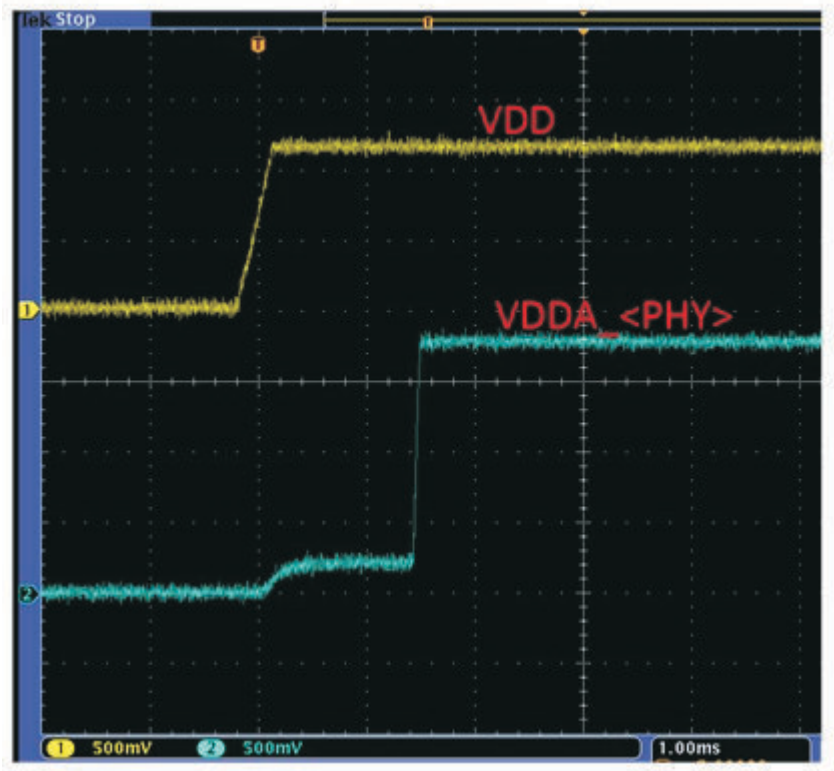
Figure 4-2. Leakage Voltage

A current path exists between VDD and the high speed analog PHY domain (VDDA_HDMI, VDDA_PCIE, VDDA _SATA, VDDA_USB2/3) during the supply power up and power down sequences.

The device-specific Data Manual requires Core AVS rail (VDD) to power up before the 1.8 V high speed analog PHY domain(s). When this sequence is followed, the high speed analog PHY domain will have a small step-up to a voltage plateau (< 0.5 V) that aligns to the beginning of the VDD ramp-up, and is maintained until the ramp-up of high speed analog PHY rail, as shown in Figure 4-2. Note the leakage value will differ from system to system, but will be less than 500 mV. The leakage voltage in the provided capture is approximately 250 mV.

A similar condition exists during supply power down sequence. The high speed analog PHY domain(s) are required to be powered down prior to Core AVS rail (VDD), and may cause a small plateau to exist until Core AVS rail (VDD) is ramped down.

The root cause of the voltage plateau during power-up/down sequencing is related to the parasitic diodes in logic blocks which have multiple power sources. This leakage path is not a reliability concern for this device.
