MSP430F423 Device Erratasheet

6 Detailed Bug Description

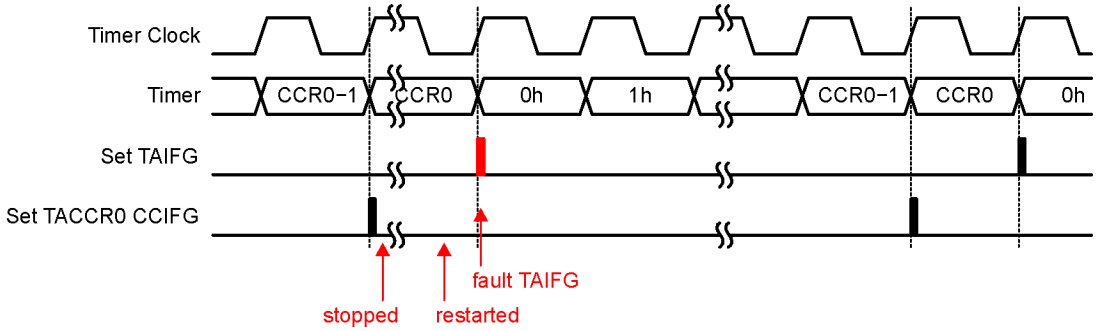
TA21 *TIMER_A Module*

Function TAIFG Flag is erroneously set after Timer A restarts in Up Mode

Description In Up Mode, the TAIFG flag should only be set when the timer counts from TACCR0 to zero. However, if the Timer A is stopped at TAR = TACCR0, then cleared (TAR=0) by setting the TACLR bit, and finally restarted in Up Mode, the next rising edge of the TACLK will erroneously set the TAIFG flag.

Workaround None.
