TCI6638K2K

Multicore DSP+ARM KeyStone II SOC

Silicon Errata

Literature Number: SPRZ401F
June 2013–Revised May 2017

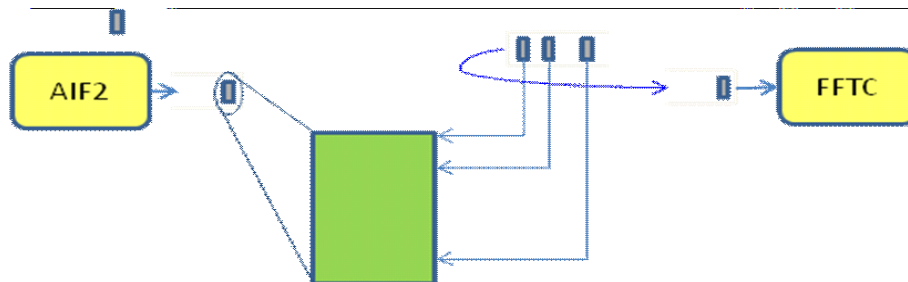
Figure 11. Symbol Processing on Ingress

- On ingress, the symbol processing is not triggered upon receiving the jumbo packet, instead it is triggered based on AT event. As AT event doesn't have association with the availability in memory, application needs to program AT event with enough offset to the actual symbol timing to guarantee the data availability in memory.
- On egress, no need to produce the entire jumbo packet before pushing the packet to AIF2, symbols can be produced on symbol basis with enough margin before AIF2 needs it. The margin is related to the pre-fetch buffer size set in AIF2.

Pre-configure a set of descriptors that point to the correct offset in jumbo packet for each symbol, store the descriptors in the FFTC Tx FDQ or an array. AT event trigger the EDMA to pop and push the descriptors from FFTC Tx FDQ to FFTC Tx Q. EDMA needs to pop the descriptor from the Tx FDQ and push to the FFTC Tx Q. If the AIF2 output packet PS words are needed, then it will need to be copied by EDMA before pushing the descriptor to the FFTC Tx Q. If using AT event to trigger EDMA, after pushing the descriptor, EDMA needs to clear the CP_INTC to prepare the subsequent AT event trigger. As there is no real need for the AIF2 output queue itself, AIF2 Rx Q can be set to be the same queue as the Rx FD, Therefore no need to recycle the AIF2 output descriptor.
