Flash Read Error and Susceptibility for MSP430F55xx

MSP430

This document provides a description of the issue referred to as “Flash Read Error” impacting the current version of the MSP430F55xx device derivatives. It also provides guidance in assessing whether and the extent to which the issue may affect a given application. Specific actions and customer recommendations are set forth in the [PCN #20100910003A](#).

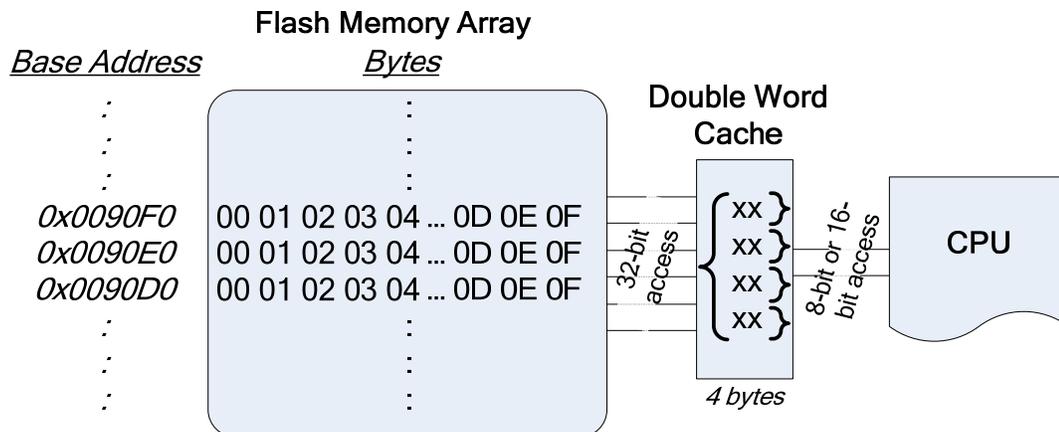
Figure 1. Simplified Cache Architecture and CPU Access

To better describe the flash read error mechanism, it is important to understand the device architecture. The MSP430F55xx implements a 32-bit cache for memory read operation – e.g. a physical read of the flash memory is performed on 32-bit boundaries; every 4 bytes, which is stored in a cache logic array. These 32-bit values are referred to as “double words”. Memory access by the CPU to individual bytes and words is then done by accessing the cache. This cache architecture is shown in Figure 1.
