TMS320C6748 Fixed- and Floating-Point DSP Silicon Revisions 2.3, 2.1, 2.0, 1.1 and 1.0

Silicon Errata

Literature Number: SPRZ303H
June 2009–Revised March 2014

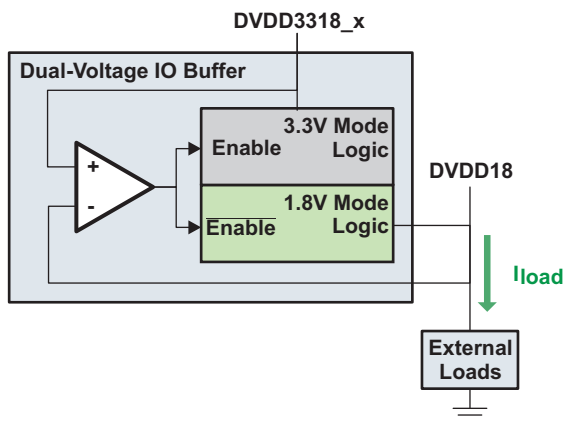
The condition occurs because the dual-voltage IO buffers have voltage detection circuitry that monitors DVDD3318_x during reset and determines whether the applied supply voltage is 1.8V or 3.3V. This detection circuitry then configures the IOs to operate at the appropriate voltage. As the DVDD3318_x supply ramps, there is a small range near DVDD18 + V_T where the voltage detection circuit finds the state indeterminate and briefly turns on circuitry associated with both voltage options creating a current path between them. This current path can cause the DVDD18 supply to be pulled up. The mechanism for this behavior is explained below:

Behavior of the IO buffer during Zone F:

As the DVDD3318_x supply ramps, but is not yet one V_T above the DVDD18 supply, the comparator enables the 1.8V mode logic section and disables the 3.3V mode logic section. No unexpected current flows between the two sections.

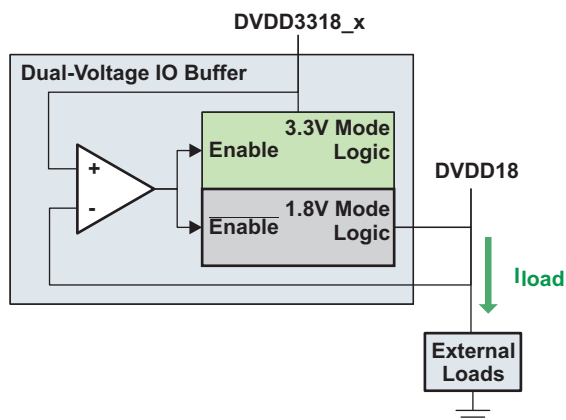
Recovered State of the IO buffer during Zone G:

If the load current is high enough or the DVDD18 power supply can oppose the leakage current, then the DVDD18 voltage stays low enough for:

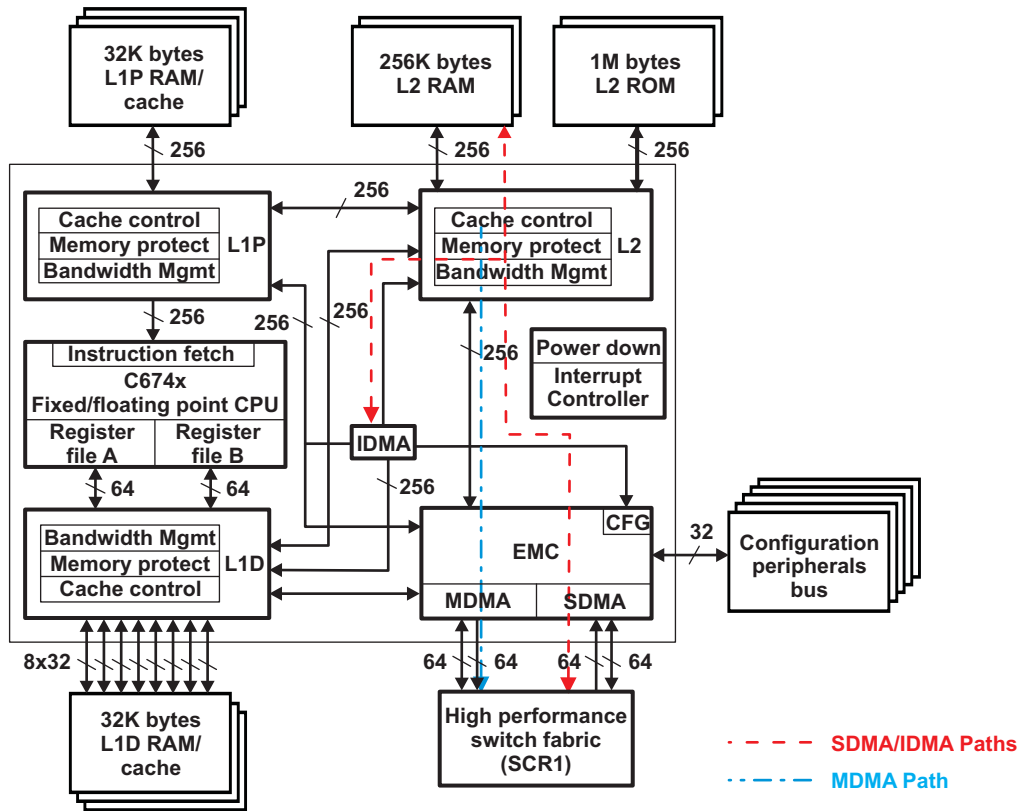
Figure 14. C674x Megamodule

Ideally, the MDMA (dashed-dotted line in Figure 14) and SDMA/IDMA paths (dashed lines in Figure 14) operate independently with minimal interference. Normally MDMA accesses may stall for extended periods of time due to expected system level delays (for example, bandwidth limitations). However, when using L2 as RAM, SDMA and IDMA accesses to L2/L1 may experience unexpected stalling in addition to the normal stalls seen by the MDMA interface. For latency-sensitive traffic, the SDMA stall can result in missing real-time deadlines. In a more severe case, the SDMA stall can produce a deadlock condition in the device. An IDMA stall cannot produce a deadlock condition.

Note: SDMA/IDMA accesses to L1P/D will not experience an unexpected stall if there are no SDMA/IDMA accesses to L2. Unexpected SDMA/IDMA stalls to L1 happen only when they are pipelined behind L2 accesses. Additionally, the deadlock scenario will be avoided if there are no SDMA accesses to L2.

Figure 14 is provided for illustrative purposes and is incomplete because of simplification. The IDMA/SDMA (dashed-lines) path could also go to L1D/L1P memories, and IDMA can go to DSP CFG peripherals. MDMA transactions can originate also from L1P or L1D through the L2 controller or directly from DSP).

The duration of the SDMA/IDMA stalls depend on the quantity/characteristics of the L1/L2 cache and the MDMA traffic in the system. Therefore, it is difficult to predict if stalling will occur and for how long.
