AM1705 ARM Microprocessor Silicon Revisions 3.0, 2.1, and 2.0

Silicon Errata

Literature Number: SPRZ311E
March 2010–Revised June 2014

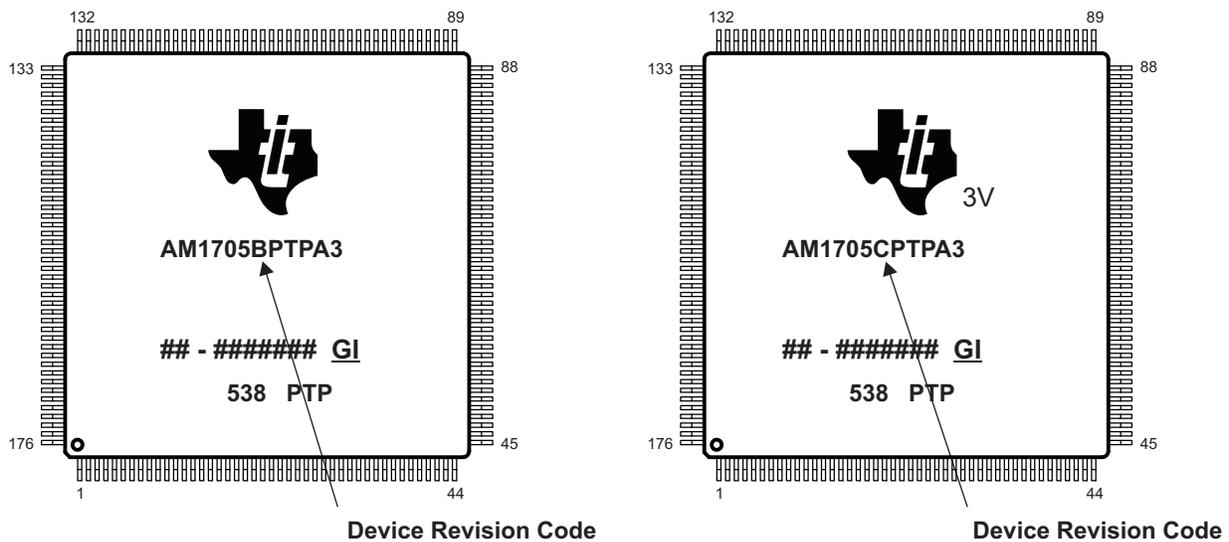
Example, Device Revision Codes for AM1705 (PTP Package)

[Table 1](#) lists the device revision codes for the AM1705 processor, as well as shows the relationship between the device revision codes and silicon revisions.
