Stellaris® LM3S9B92 RevB1 Errata

This document contains errata as of October 2013 for the Stellaris LM3S9B92 microcontroller. Additional errata added after October 2013 that apply to revision B1 can be found in the *Stellaris® LM3S Tempest- and Firestorm-Class Microcontrollers Errata (SPMZ861)*. Read both documents for the complete list of errata for your device.

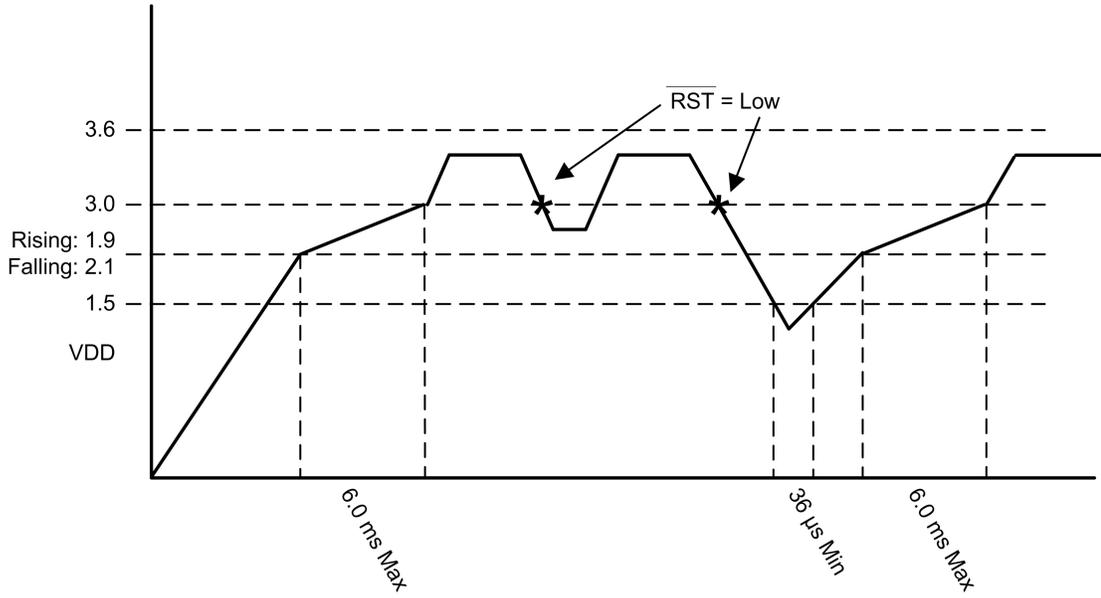
Figure 1. VDD Waveform Signature Limits

1. The VDD power-up, steady state, and power-down waveform meets the timing requirements shown in Figure 1 on page 14.
2. The power-up transition of VDD between 1.9 V and 3.0 V must not have any points where it decreases in voltage (must be monotonic).
3. The power-down transition of VDD between 3.0 V and 1.5 V must not have any points where it increases in voltage (must be monotonic).
4. Once steady-state operation between 3.0 V and 3.6 V is achieved, $\overline{\text{RST}}$ must go Low or the CPU execution must be halted prior to VDD falling below 3.0 V.
5. The **Brown-Out Reset Control (PBORCTL)** register must be set so that a brown-out event causes a reset.

Depending on the system environment requirement, items 3, 4, and 5 in the above list may be met by using a voltage supervisor, such as the TLV803M, to monitor a higher voltage rail from which the VDD supply is regulated. Figure 2 on page 14 shows this implementation with a voltage supervisor monitoring the 5-V rail and a voltage trip point of 4.38 V. A voltage supervisor with a lower voltage trip point can be used to monitor the VDD (3.3-V) rail, however this supervisor must assert reset before VDD reaches 3.0 V. Regardless of the implemented voltage supervisor circuit, the system designer must ensure that there is enough time to assert $\overline{\text{RST}}$ Low prior to VDD falling below 3.0 V. Figure 3 on page 15 shows the resulting waveform of the circuit shown in Figure 2 on page 14.
