TMS320TCI6618

Communications Infrastructure KeyStone SoC

Silicon Revisions 1.0, 2.0

Silicon Errata

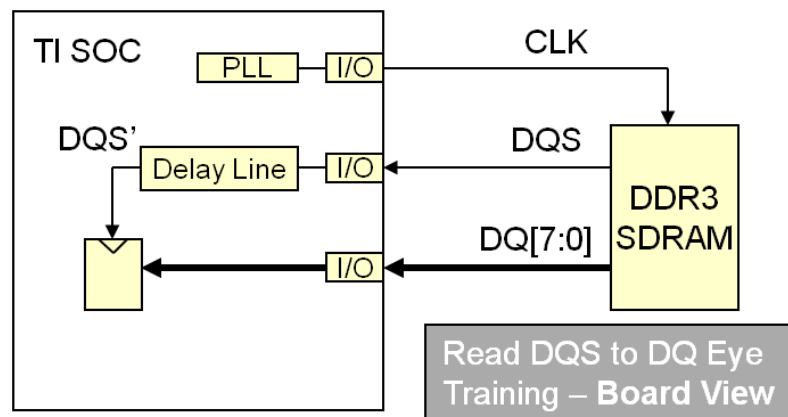
Figure 12 Read DQS to DQ Eye Training - Board View

The intended purpose of the Read Data Eye Training feature is to align the DQS sampling transitions in the middle of the DQ data eye within individual byte lanes of the DDR3 memory interface. As seen in [Figure 12](#), the DQS signal can be delayed relative to the DQ signal within the DDR3 PHY.

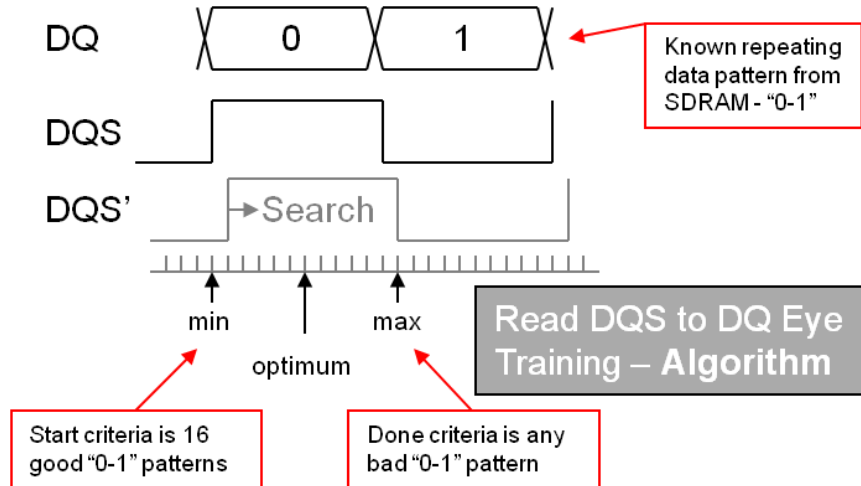
Figure 13 Read DQS to DQ Eye Training - Algorithm

As shown in Figure 13, the Read Data Eye Training algorithm should correctly detect the extents of the DQ data eye. The SDRAM is put into a DQS-to-DQ eye training mode and read back an alternating 0, 1 pattern.

The DDR3 PHY uses this pattern to detect good or bad data being sampled by the DQS transitions. The DDR3 PHY searches by delaying DQS relative to DQ until these constraints are found.

However, if too much jitter is present on the DQ or DQS signals, the search can converge to a false edge as shown in Figure 14.
