Stellaris® LM3S Tempest- and Firestorm-Class Microcontrollers Errata

Silicon Errata

Literature Number: SPMZ861

July 2014

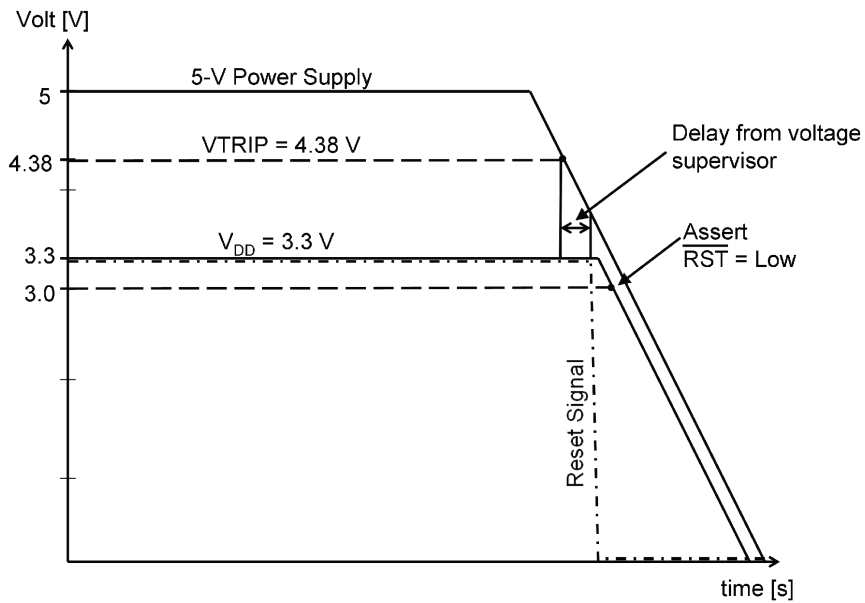
Figure 5. Resulting Waveform Using the Voltage Supervisor Circuit

Depending on the system environment requirement, items 3, 4, and 5 in the above list may be met by using a voltage supervisor, such as the TLV803M, to monitor a higher voltage rail from which the VDD supply is regulated. Figure 4 shows this implementation with a voltage supervisor monitoring the 5-V rail and a voltage trip point of 4.38 V. A voltage supervisor with a lower voltage trip point can be used to monitor the VDD (3.3-V) rail, however this supervisor must assert reset before VDD reaches 3.0 V. Regardless of the implemented voltage supervisor circuit, the system designer must ensure that there is enough time to assert RST Low prior to VDD falling below 3.0 V. Figure 5 shows the resulting waveform of the circuit shown in Figure 4.
