TMS320TCI6482

Digital Signal Processor

Silicon Revisions 3.1, 2.1, 2.0, 1.1

Silicon Errata

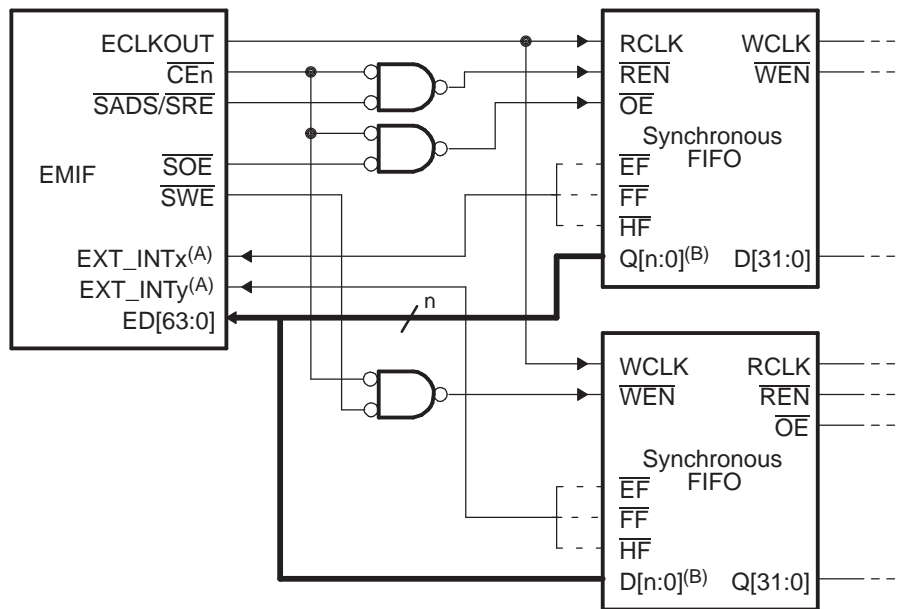
Figure 2. Read and Write Synchronous FIFO Interface With Glue Block Diagram

The state of the EMIFA control pins is not defined while the chip enable pins ($\overline{CE[5:2]}$) are high. Furthermore, some control pins may become active while the chip enable pins are driven high. To avoid erroneously activating devices connected to EMIFA, the chip enable pins should be used to select/deselect these devices. If a device being used does not have a chip enable input, then the control pins going to that device should be qualified with a chip enable pin. An example of this is shown in [Figure 2](#).

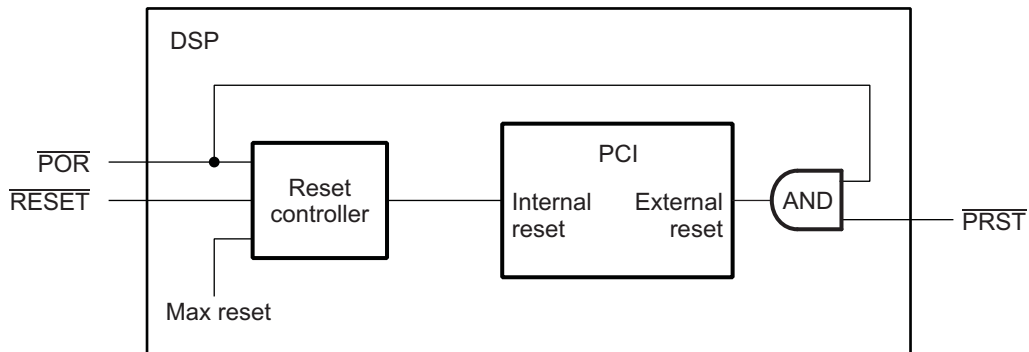
Figure 5. Internal Reset Asserted By Reset Controller

Details: The PCI module in the TCI6482 device has an internal and an external reset source. The internal reset is asserted by the reset controller during power-on, warm, and max reset, see Figure 5. The internal reset is also asserted when the device state control registers are used to disable the PCI module. The external reset is asserted through the PCI reset pin, \overline{PRST} .

The PCI module can lock up or go into a bad state if its internal and external resets are asserted independently, meaning one is asserted and the other is not. Power-on and warm reset are controlled differently from system to system and, therefore, the effect of this issue is system specific.

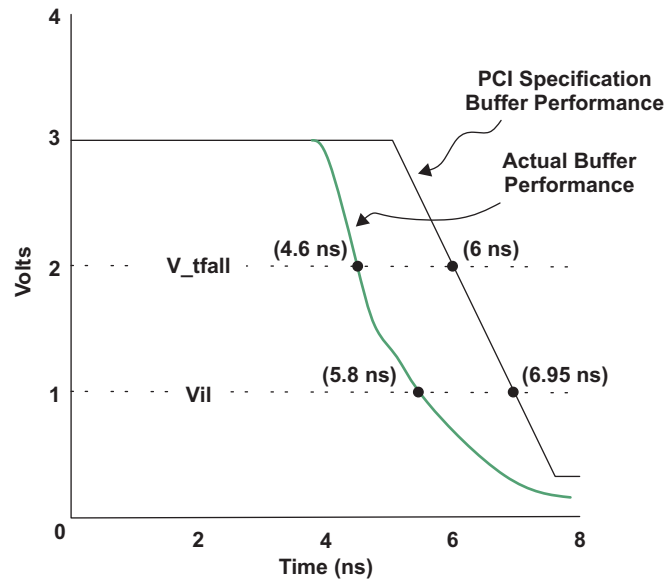
Figure 11. 66-MHz Buffer Slew and Timing Performance vs Specification Performance

Although the actual minimum slew rate is below the specified minimum, overall PCI timings are within the bounds permitted by the PCI specification. As shown in [Table 11](#), actual values for the valid signal delay (T_{val}) are well below the permitted maximum. This allows additional time for system propagation delay to compensate for the reduced slew rate. [Figure 11](#) shows the buffer slew and timing performance versus the specification performance in the 66-MHz environment. The 33-MHz environment has even more timing margin than the 66-MHz environment, making 66 MHz the worst case.

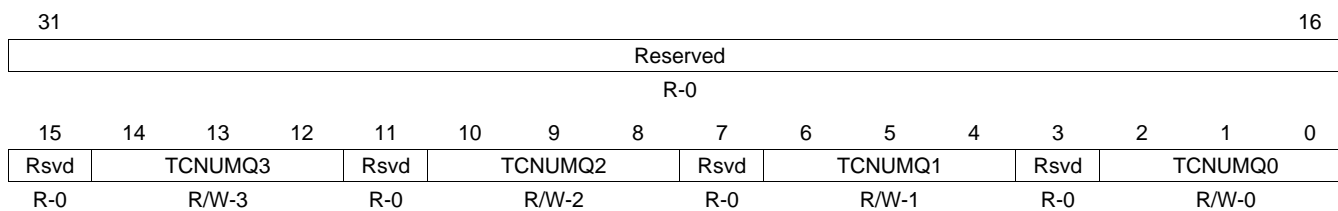
Figure 16. QUETCMAP Register (02A0 0280h)

For example, abiding by the default settings, McBSP events need to be submitted on Q1 since TC1 is the only TC with connectivity to this peripheral. McBSP transfers might be at risk if there are events pending on Q0. In order to reduce this risk, the default mapping of Q0 can be changed such that it maps to TC1. In this manner, an event on Q0 results in a TR submission to TC1 thus minimizing the risk of a real-time miss due to this issue.

2. By default, each queue maps directly to a corresponding transfer controller (TC); i.e., Q0 maps to TC0, Q1 maps to TC1, etc. If there is a real-time requirement for servicing a peripheral which cannot be accessed via TC0, then Q0 can be mapped to the TC through which the peripheral can be accessed. Queue to TC mapping can be changed via software through the QUETCMAP register (see [Figure 16](#) and [Table 19](#)) as long as only one queue maps to one TC.

Opting for this workaround has other implications on the system. For example, if Q0 is mapped to TC1 then another queue must be mapped to TC0. If Q1 is mapped to TC0, the VCP2 and TCP2 events must be submitted on Q1. Whether this is acceptable would need to be determined by the user.
