TMS320TCI6487/8

Digital Signal Processor

Silicon Revisions 2.1, 2.0, 1.3, 1.2, 1.1, 1.0

Silicon Errata

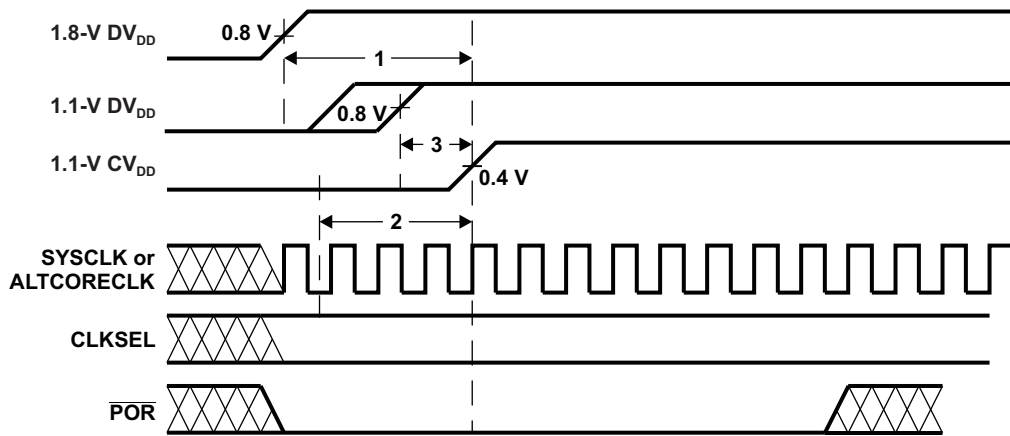
Figure 14. Correct Device Input Clocks, Clock Selects, and Scaled Supply Timings

Guarantee that the 1.8-V DV_{DD} device input clocks and clock selects are active before a 1.1-V CV_{DD} scaled supply ramps (see [Table 22](#) and [Figure 14](#)).

NO.	PARAMETERS	MIN	MAX	UNITS
1	DV_{DD18} at 0.8 V to CV_{DD} at 0.4 V	0.5		ms
2	Stable clock to CV_{DD} at 0.4 V	100		μ s
3	DV_{DD11} at 0.8 V to CV_{DD} at 0.4 V	0.5		μ s
