TMS320DM357

Digital Media System-on-Chip

Silicon Revision 2.1

Silicon Errata

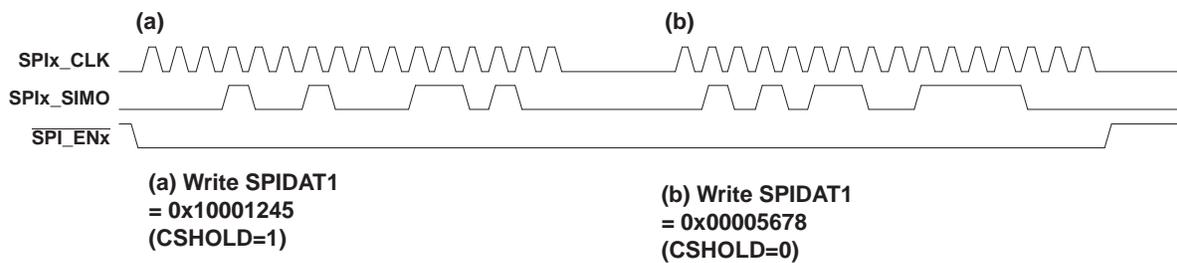
Figure 2. Expected CSHOLD Behavior

According to the SPI specification, the following sequence should produce the expected result as illustrated in [Figure 2](#):

- Write 0x10001234 to SPIDAT1 for transmission of 0X1234 (CSHOLD = 1)
- Write 0x00005678 to SPIDAT1 for transmission of 0x5678 (CSHOLD = 0)

Instead, what actually occurs is that $\overline{\text{SPI_ENx}}$ is momentarily de-asserted at the beginning of the second write, as illustrated in [Figure 3](#).
