TMS320DM6467T
Digital Media System-on-Chip (DMSoC)
Silicon Revision 3.0

Silicon Errata

Literature Number: SPRZ307A
January 2010–Revised July 2010

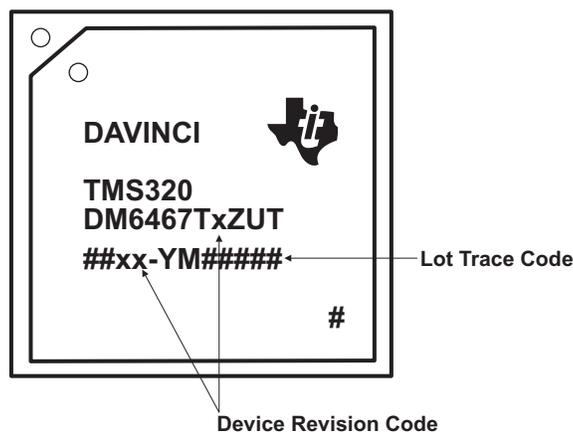
Figure 1. Example, Device Revision Codes for TMS320DM6467T (ZUT Package)

Silicon Revision and date of manufacturing are identified by device-revision code and lot trace code markings on the package. The codes are of the format ##xx-YM##### where "xx" denotes the Die PG Code. If xx is "30" then the silicon is revision 3.0 and the device part number (x) has *no letter* (blank). Table 1 lists the information associated with each silicon revision. "YM" in the lot trace code denotes the manufacturing date in Hex, where "Y" denotes the year and "M" denotes the month. For example, if "YM" is "9B", then the part is manufactured in 2009 November.
