# AM3715, AM3703 Sitara ARM Microprocessors Silicon Revisions 1.2, 1.1, 1.0

## Silicon Errata

Literature Number: SPRZ318F  
June 2010–Revised April 2014

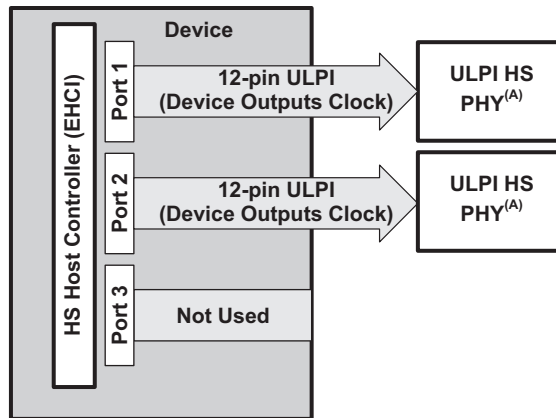
**Figure 6. Connecting to High-Speed PHYs Using USB Ports**

As shown in Figure 6, USB Port 1 and Port 2 can be used to connect to external high-speed PHYs which include a ULPI port. However, in this case, the external USB PHY must be able to accept a source clock generated by the AM37x high-speed USB controller. Also, in this usage model the USB ports cannot support full-speed and low-speed operation. Therefore, using this approach, USB Port 1 and Port 2 cannot provide a fully compliant USB 2.0 Type-A receptacle; a high-speed USB hub would be required in this case; please see Figure 7.

A. USB port 3 does not support ULPI mode. Also, USB port 3 not available on CUS package.

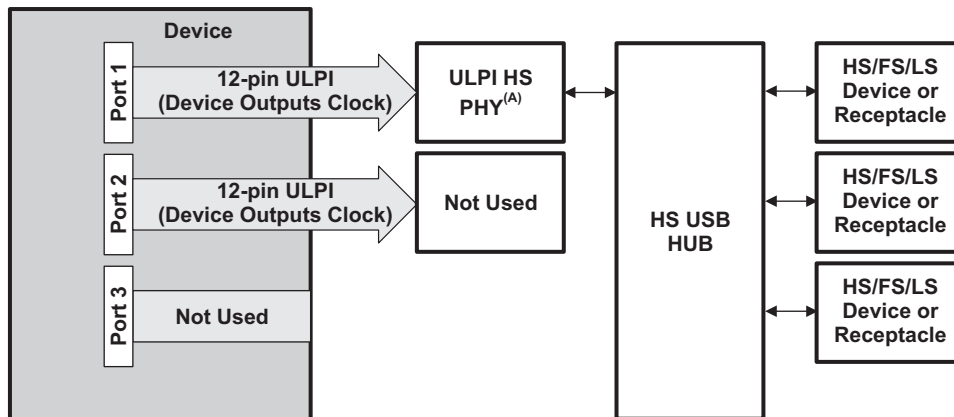
**Figure 7. Connecting to a High-Speed USB Hub**

A. USB port 3 does not support ULPI mode. Also, USB port 3 not available on CUS package.
