TMS320TCI6608
Multicore Fixed and Floating-Point Digital
Signal Processor
Silicon Revision 1.0, 2.0

Silicon Errata

Literature Number: SPRZ333H
January 2011–Revised July 2015

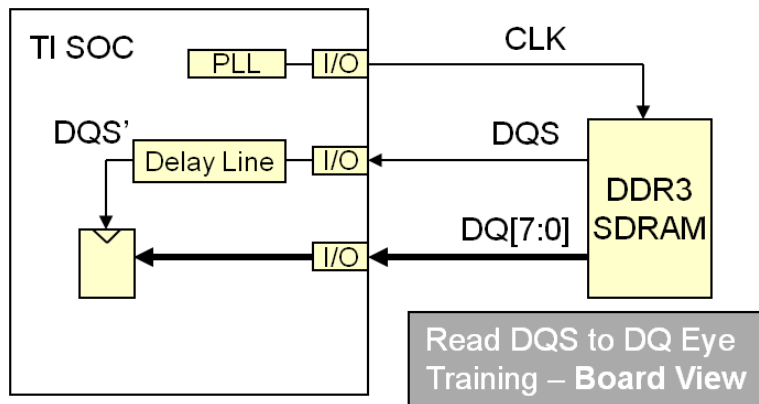
Figure 2. Read DQS to DQ Eye Training - Board View

The leveling feature with the problem is the Read Data Eye Training. Depending on the jitter seen on the DQ and DQS signals, this leveling feature will fail to converge on a good data eye, resulting in corrupted DSP to DDR3 SDRAM reads.

The intended purpose of the Read Data Eye Training feature is to align the DQS sampling transitions in the middle of the DQ data eye within individual byte lanes of the DDR3 memory interface. As seen in [Figure 2](#), the DQS signal can be delayed relative to the DQ signal within the DDR3 PHY.

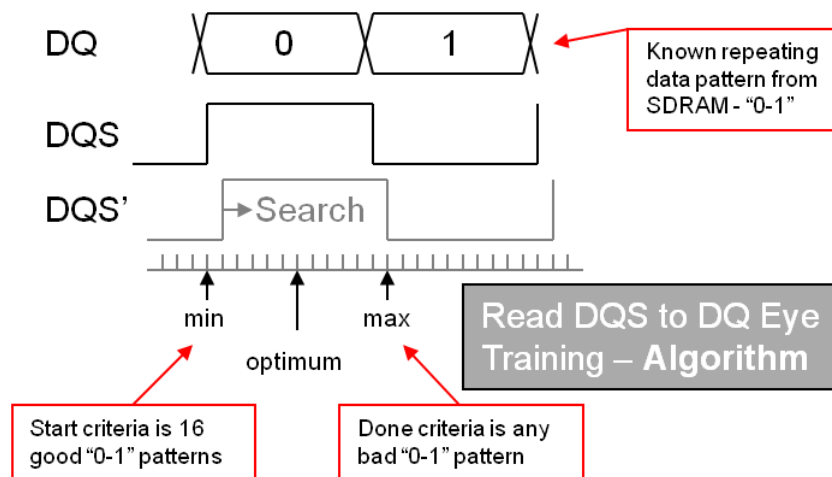
Figure 3. Read DQS to DQ Eye Training - Algorithm

As shown in [Figure 3](#), the Read Data Eye Training algorithm should correctly detect the extents of the DQ data eye. The SDRAM are put into a DQS to DQ eye training mode and read back an alternating 0, 1 pattern.

The DDR3 PHY uses this pattern to detect good or bad data being sampled by the DQS transitions. The DDR3 PHY searches by delaying DQS relative to DQ until these constraints are found.
