TMS320TCI6614

Communications Infrastructure KeyStone SOC

Silicon Revisions 1.0, 1.1, 1.3

Silicon Errata

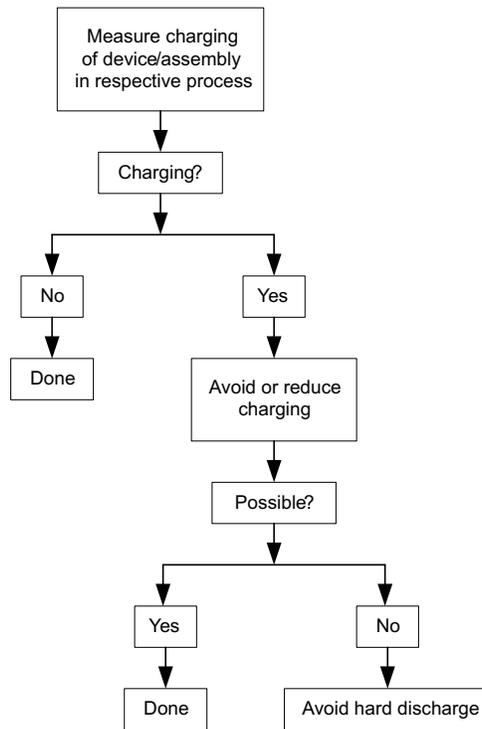
Figure 3. Basic Flow for Analyzing CDM Risk

Details: All data manual specifications associated with the SerDes high-speed functional pins are guaranteed to a maximum component Electrostatic Discharge - Charged Device Model (ESD-CDM) pulse threshold of 150 V.

Due to the sensitive nature of the SerDes high-speed pins, exceeding component ESD CDM stress pulses of 150 V on the functional pins listed below may cause permanent changes to the output swing and the de-emphasis behavior associated with these pins.

Workaround: While there is no strict workaround for this issue, there are several ways to analyze the risk with regards to CDM. [Figure 3](#) shows the basic flow for analyzing this risk:

Using generally accepted good practices during the assembly process can help to minimize the likelihood of a hard discharge. These practices include:

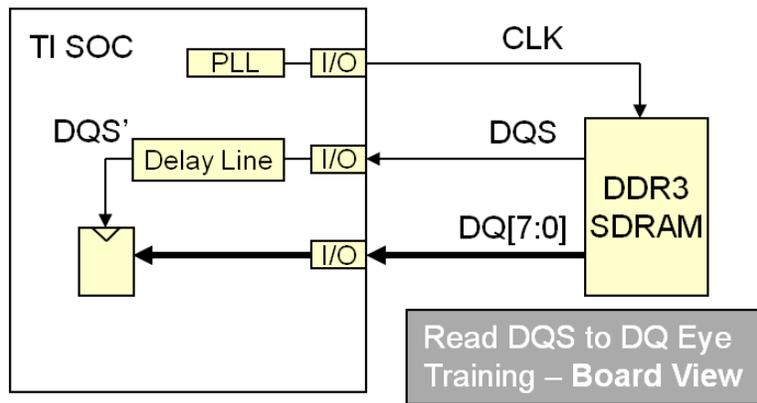
Figure 6. Read DQS to DQ Eye Training - Board View

The leveling feature with the problem is the Read Data Eye Training. Depending on the jitter seen on the DQ and DQS signals, this leveling feature will fail to converge on a good data eye, resulting in corrupted DSP to DDR3 SDRAM reads.

The intended purpose of the Read Data Eye Training feature is to align the DQS sampling transitions in the middle of the DQ data eye within individual byte lanes of the DDR3 memory interface. As seen in [Figure 6](#), the DQS signal can be delayed relative to the DQ signal within the DDR3 PHY.

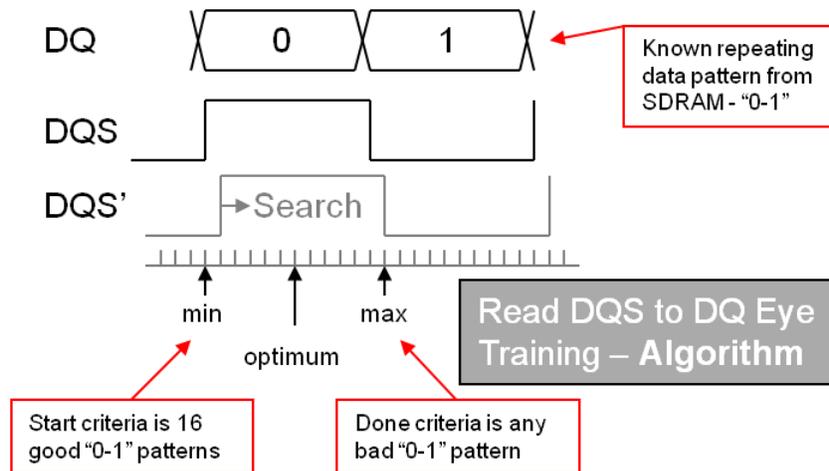
Figure 7. Read DQS to DQ Eye Training - Algorithm

As shown in [Figure 7](#), the Read Data Eye Training algorithm should correctly detect the extents of the DQ data eye. The SDRAM are put into a DQS to DQ eye training mode and read back an alternating 0, 1 pattern.

The DDR3 PHY uses this pattern to detect good or bad data being sampled by the DQS transitions. The DDR3 PHY searches by delaying DQS relative to DQ until these constraints are found.

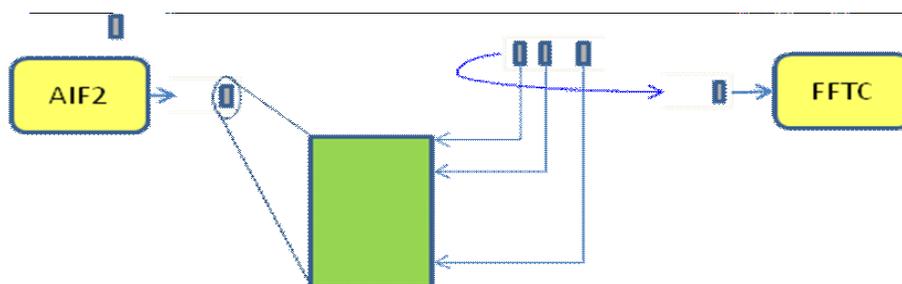
Figure 14. Symbol Processing on Ingress

- On ingress, the symbol processing is not triggered upon receiving the jumbo packet, instead it is triggered based on AT event. As AT event doesn't have association with the availability in memory, application needs to program AT event with enough offset to the actual symbol timing to guarantee the data availability in memory.
- On egress, no need to produce the entire jumbo packet before pushing the packet to AIF2, symbols can be produced on symbol basis with enough margin before AIF2 needs it. The margin is related to the pre-fetch buffer size set in AIF2.

Pre-configure a set of descriptors that point to the correct offset in jumbo packet for each symbol, store the descriptors in the FFTC Tx FDQ or an array. AT event trigger the EDMA to pop and push the descriptors from FFTC Tx FDQ to FFTC Tx Q. EDMA needs to pop the descriptor from the Tx FDQ and push to the FFTC Tx Q. If the AIF2 output packet PS words are needed, then it will need to be copied by EDMA before pushing the descriptor to the FFTC Tx Q. If using AT event to trigger EDMA, after pushing the descriptor, EDMA needs to clear the CP_INTC to prepare the subsequent AT event trigger. As there is no real need for the AIF2 output queue itself, AIF2 Rx Q can be set to be the same queue as the Rx FD, Therefore no need to recycle the AIF2 output
