J721E DRA829/TDA4VM Processors Silicon Revision 2.0/1.1/1.0

ABSTRACT

This document describes the known exceptions to the functional specifications (advisories). This document may also contain usage notes. Usage notes describe situations where the device's behavior may not match presumed or documented behavior. This may include behaviors that affect device performance or functional correctness.

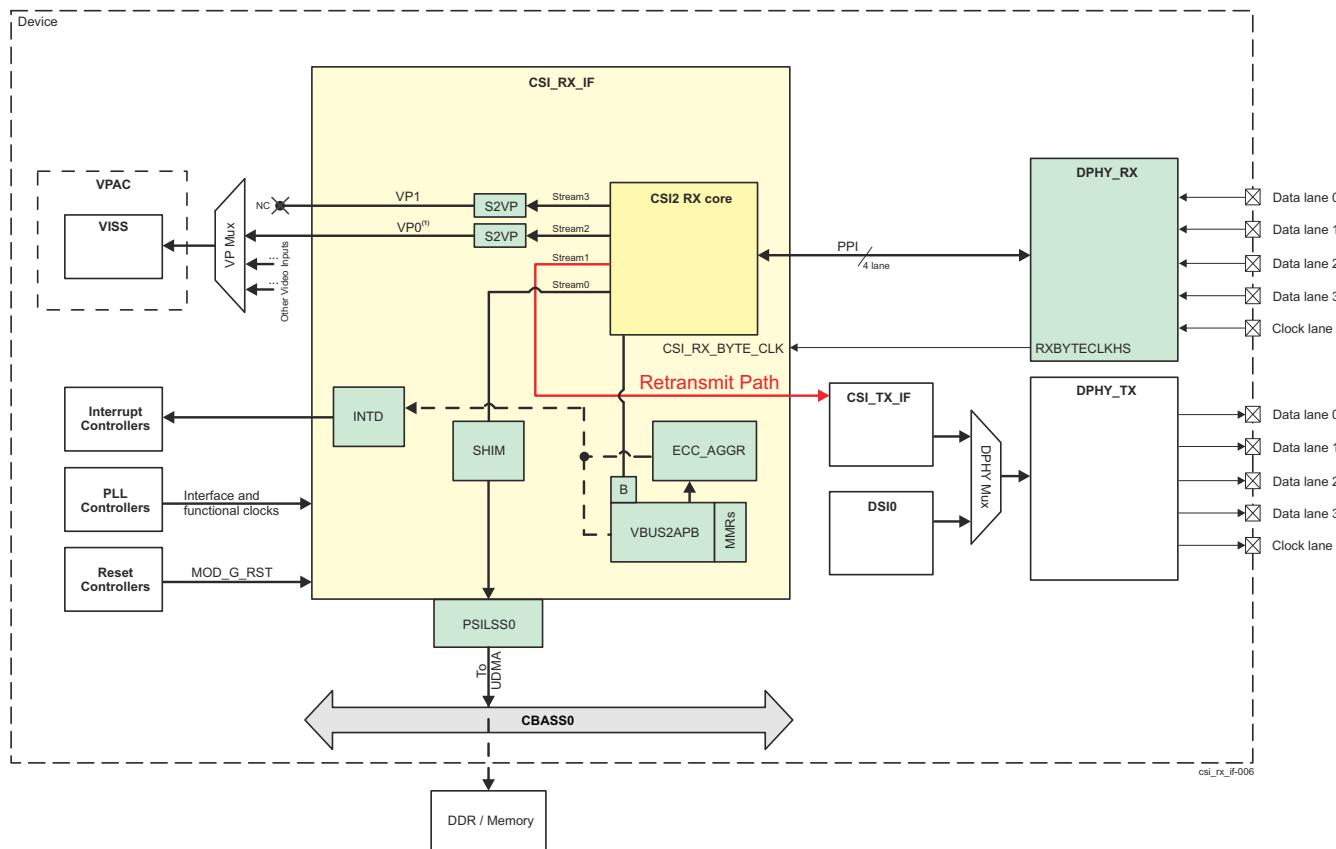
Figure 3-1. CSI_RX_IF Block Diagram
Workaround(s):

i2052 (continued)
CSI: CSI-Rx to CSI-Tx Retransmit Path Is Unavailable

Loop data through internal or external memory:

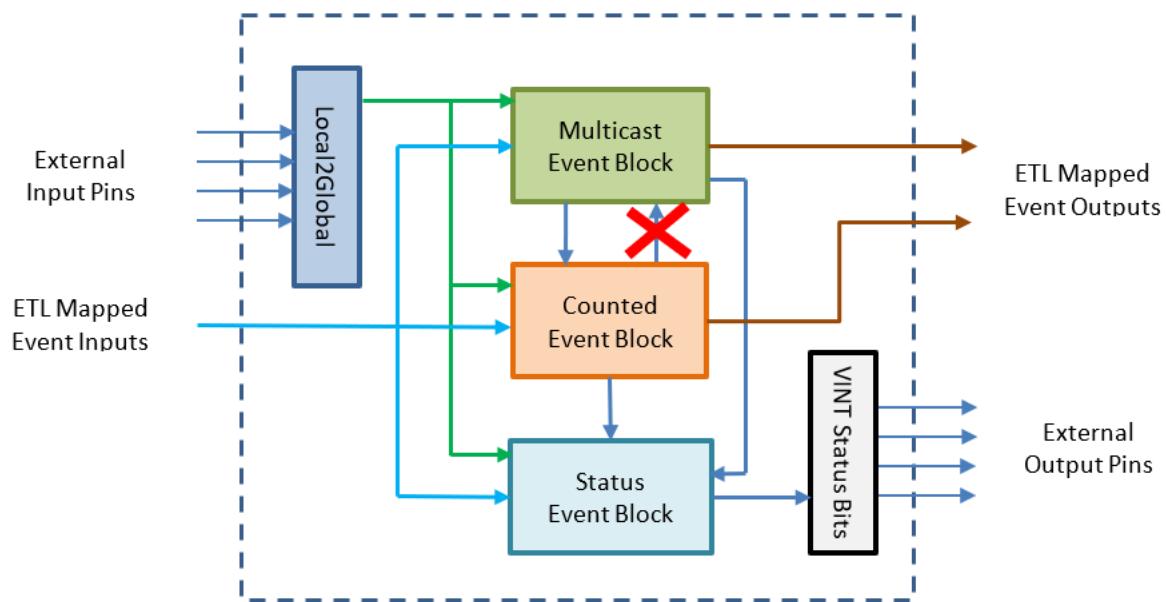
Figure 3-5. Interrupt Aggregator Version 1.0

i2196 (continued)***IA: Potential deadlock scenarios in IA***

[Figure 3-5](#) shows the conceptual block diagram of IA 1.0. Potential loops are avoided by adopting the policy of not allowing the counted event block to send events to the multicast block. This method was chosen because it is more common to split an event first, and then count one while sending the other elsewhere. With this path blocked by convention, it is not possible for a single event to visit any block more than once and thus not possible for paths to become blocked so long as the outputs remain unblocked.

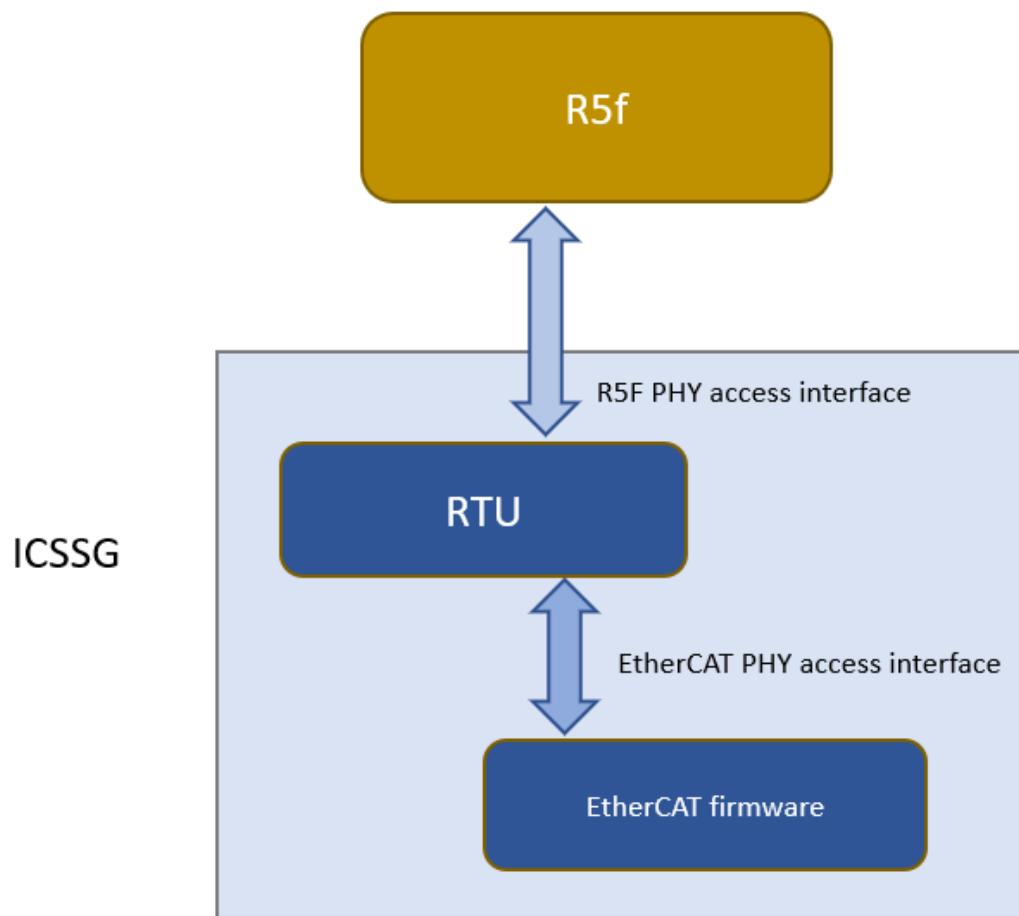
Figure 3-6. MDIO Emulation via Manual Mode using PRU Core

MDIO: MDIO interface corruption (CPSW and PRU-ICSS)
