# MSP430F5328 Device Erratasheet

The revision of the device can be identified by the revision letter on the [Package Markings](#) or by the [HW\\_ID](#) located inside the TLV structure of the device

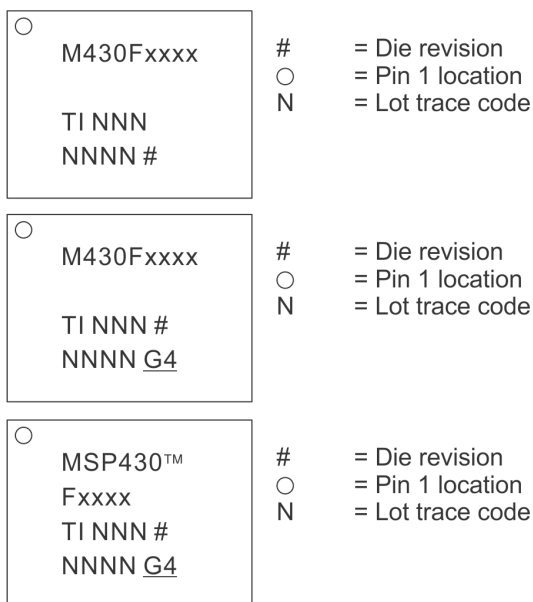
**RGC64**                      *QFN (RGC), 64 pin*

NOTE: Package marking with "TM" applies only to devices released after 2011.

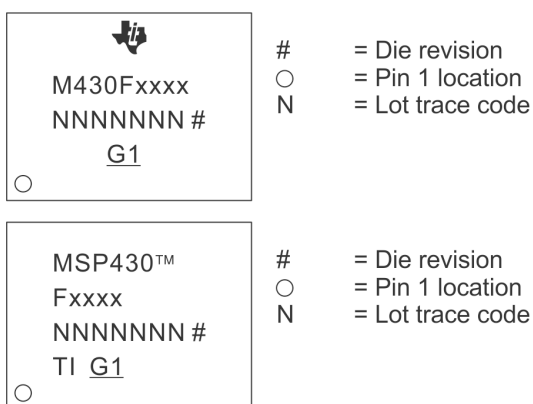
## ZQE80

### BGA (ZQE), 80 pin

NOTE: Package marking with "TM" applies only to devices released after 2011.
