## 基于 KeyStone 器件建立鲁棒性系统

冯华亮, 向展, 卢璟, 尹志新

对于复杂的系统，鲁棒性是非常重要的。为了协助客户建立鲁棒性系统，KeyStone 器件提供了多种硬件保护机制，如内存保护、EDC。本文介绍如何利用这些特性在 KeyStone 器件上建立一个鲁棒的系统。同时提供了与文档配套的例程。

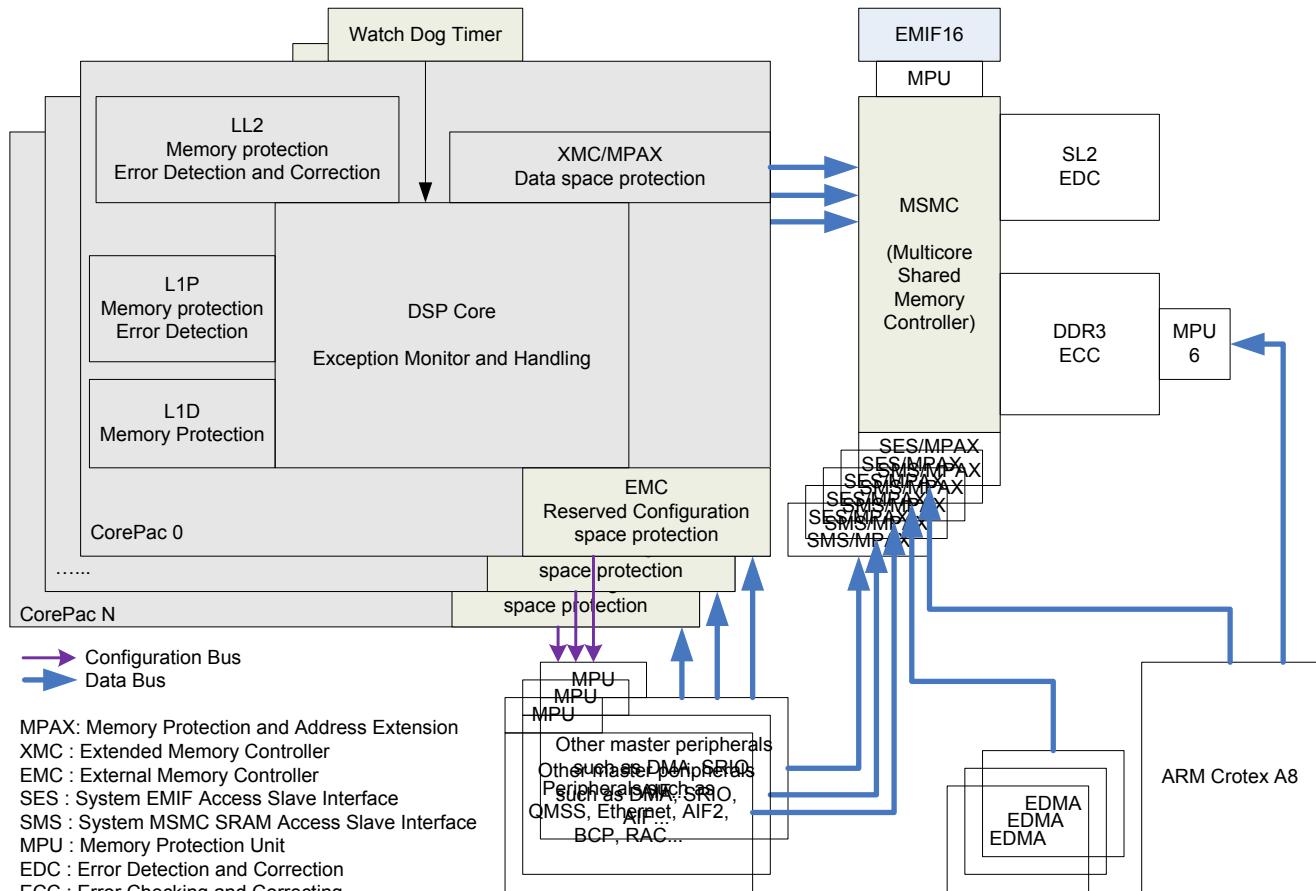
图 1 KeyStone 器件鲁棒系统

如图 1 所示, 在 LL2、L1P 及 L1D 中集成了内存保护模块; LL2、SL2 及 DDR 控制器中集成了错误检查纠正模块; L1P 集成了错误检测模块。

MPAX 和 MPU 模块附在总线上, 用于监控检测以避免非法的总线访问。

每个 DSP CorePac 有一个独立的 MPAX 用于监控与 MSMC 连接的总线。

对于系统中其他的 master, 根据权限 ID 进行分类。对每个权限 ID, 在 MSMC 中集成了 2 个 MPAX 用于监视与该权限 ID 相关的访问。其中一个是 SES MPAX 用于保护对 DDR3 的访问, 另一个 SMS MPAX 用于保护对 SL2 的访问。关于每个 master 对应的权限 ID, 参考相应的器件手册。

如图 1 所示, KeyStone 器件提供了多种协助客户建立鲁棒性应用的特性。

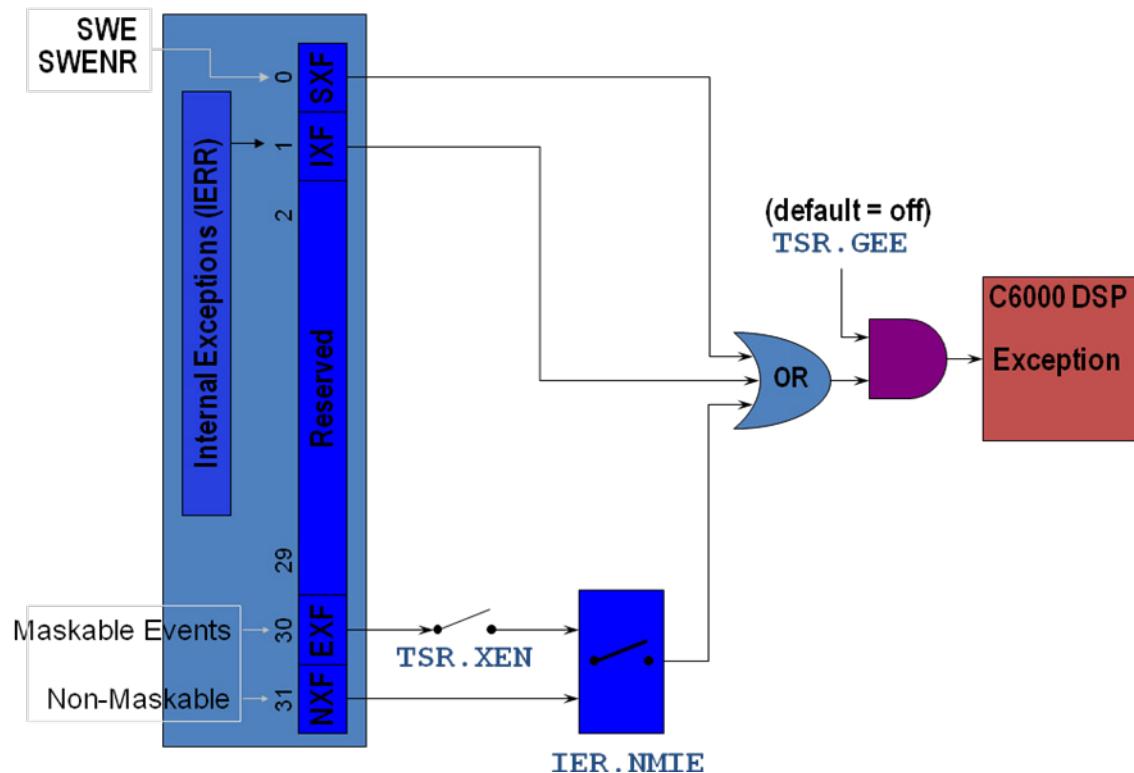
图 2 DSP 核异常控制开关

下图描述 DSP core 内部控制异常处理的开关。

一旦软件置位 TSR.GEE 及 IER.NMIE，不能再由软件清除，只能在复位后被清除。

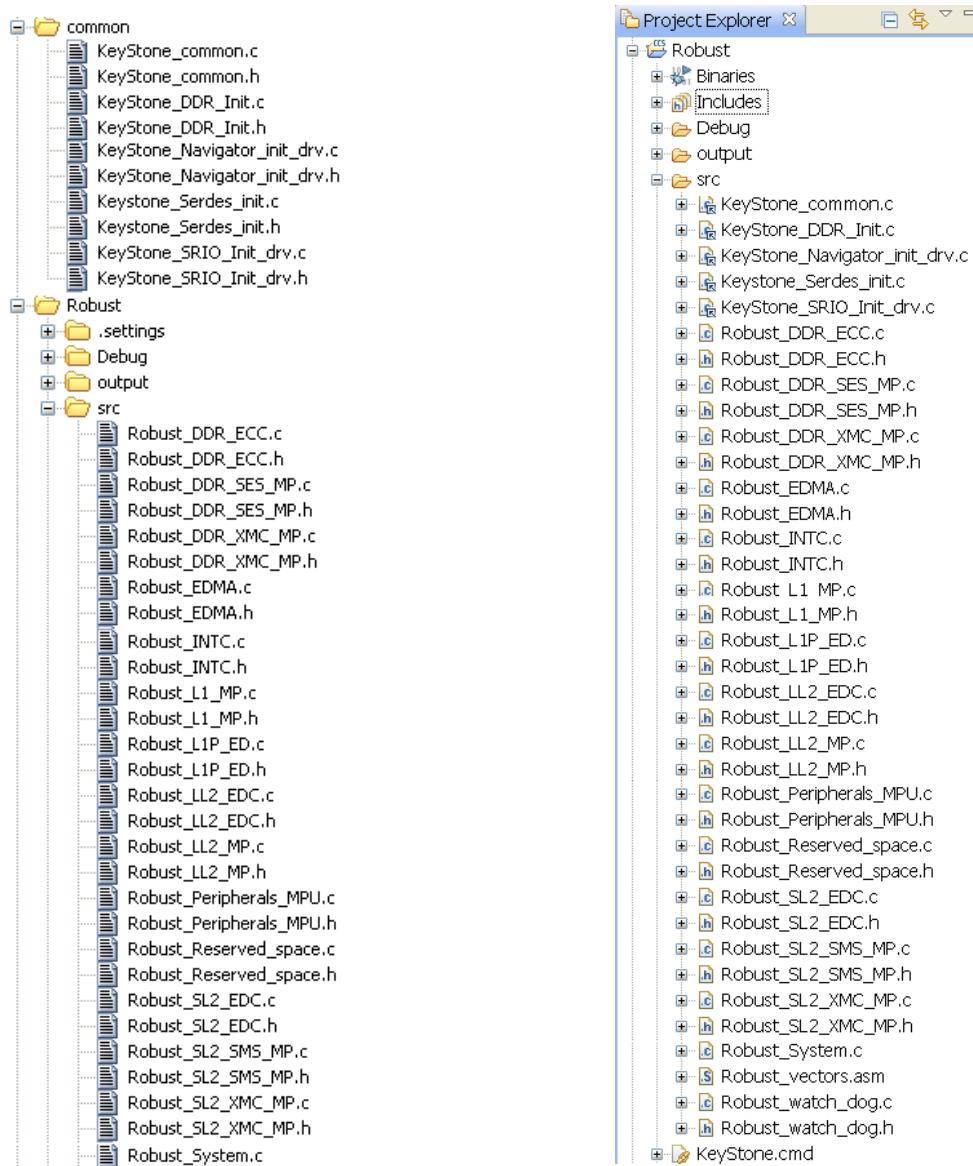
### 图 3 例程目录结果

如下为工程目录结构：

“common”文件夹中包含通用代码如 DDR 初始化及 DMA、定时器、多核导航器、SRIO 驱动等。内存保护初始化代码、EDC 及异常处理的代码包含在 KeyStone\_common.c.
