*TMS470MF0660x*  
*Microcontroller*  
**Silicon Revision B**

# Silicon Errata

Literature Number: SPNZ179A  
November 2010–Revised November 2015

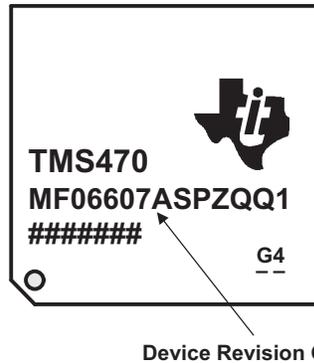
Figure 1. Example, Device Revision Code for TMS470MF0660x (PZ Package)

Figure 1 provides an example(s) of the TMS570LS series device markings. The device revision can be determined by the symbols marked on the top of the package.

Silicon revision is identified by a device revision code. The code is of the format TMS470MF06607x, where "x" denotes the silicon revision. If x is "B" in the device part number, it represents silicon version B. Table 1 lists the information associated with each silicon revision.
