MSP430F5342 Device Erratasheet

1 Functional Errata Revision History

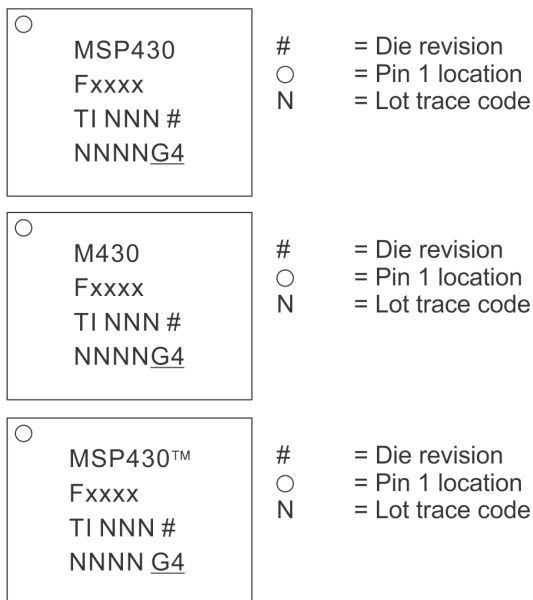
RGZ48 **QFN (RGZ), 48 Pin**

NOTE: Package marking with "TM" applies only to devices released after 2011.
