MSP430F5239 Device Erratasheet

The revision of the device can be identified by the revision letter on the [Package Markings](#) or by the [HW_ID](#) located inside the TLV structure of the device

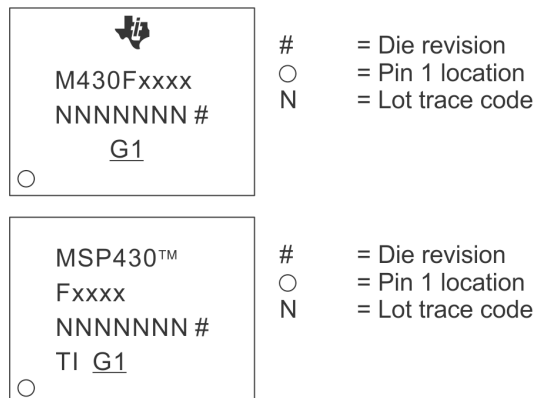
ZQE80
BGA (ZQE), 80 pin

NOTE: Package marking with "TM" applies only to devices released after 2011.
