Errata
MSP430F67451 Microcontroller

ABSTRACT

This document describes the known exceptions to the functional specifications (advisories).

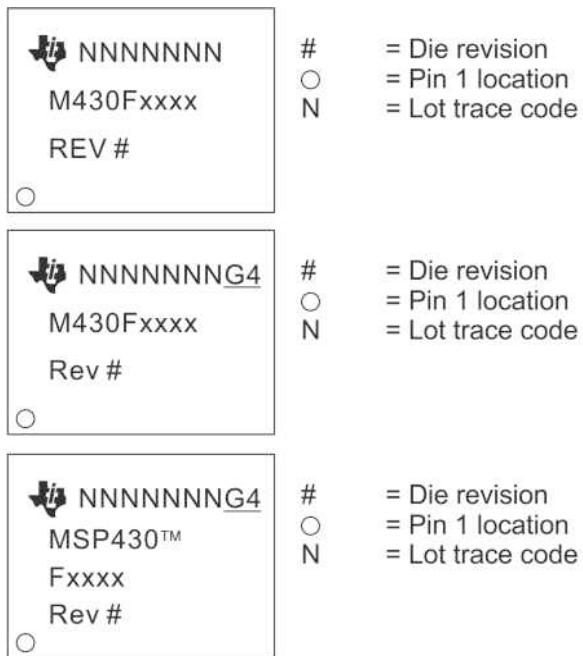
LQFP (PZ) 100 Pin

PZ100

NOTE: Package marking with "TM" applies only to devices released after 2011.
