MSP430F5237 Device Erratasheet

The revision of the device can be identified by the revision letter on the [Package Markings](#) or by the [HW_ID](#) located inside the TLV structure of the device

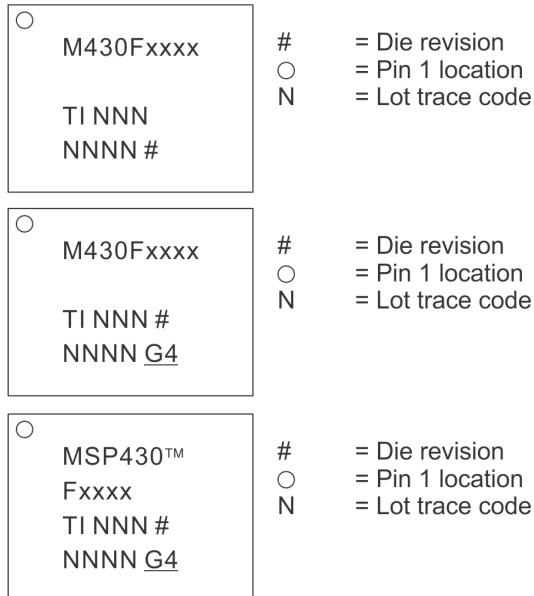
5 Package Markings**RGC64*****QFN (RGC), 64 pin***

NOTE: Package marking with "TM" applies only to devices released after 2011.

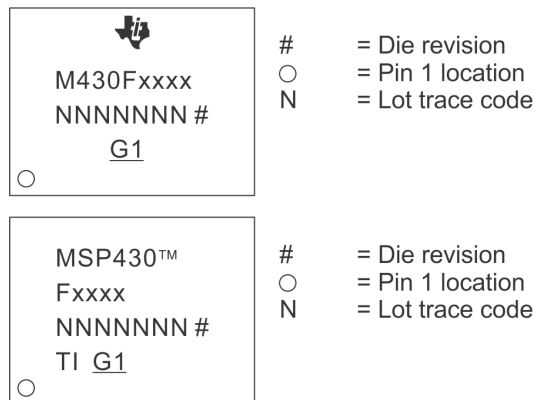
ZQE80
BGA (ZQE), 80 pin

NOTE: Package marking with "TM" applies only to devices released after 2011.
