MSP430FR6043 Device Erratasheet

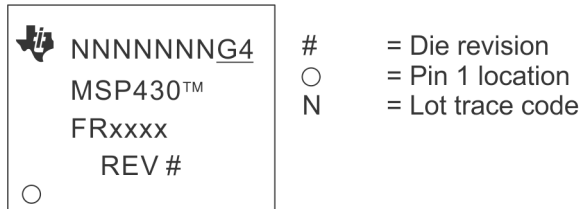
PN80
LQFP (PN), 80 Pin

5 Package Markings

The revision of the device can be identified by the revision letter on the [Package Markings](#) or by the [HW_ID located inside the TLV structure of the device](#)
