TMS320LF2406
DSP Controller
Silicon Errata

SPRZ159K
February 2000
Revised July 2003

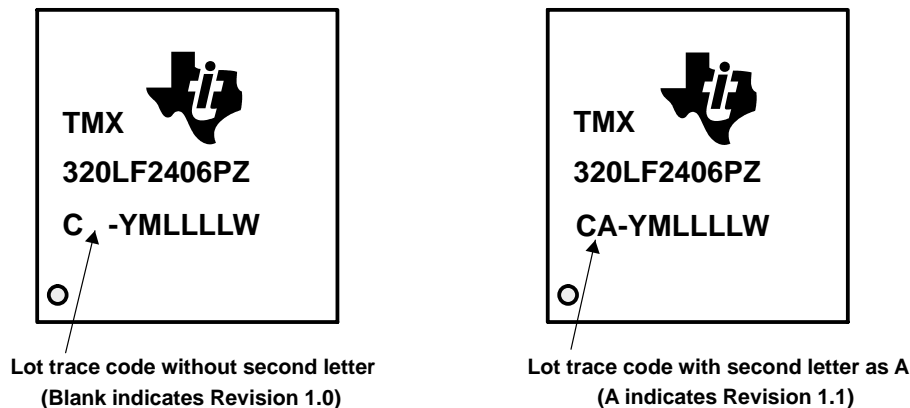
The device revision can be determined by the lot trace code marked on the top of the package. The location of the lot trace code for the PZ package is shown in Figure 1.

Figure 1. Example, Lot Trace Code for TMX320LF2406 (PZ)

Second Letter in Prefix of Lot Trace Code	Silicon Revision	Comments
Blank (no second letter in prefix)	Indicates Revision 1.0	This silicon revision is available as TMX only.
A (second letter in prefix is an "A")	Indicates Revision 1.1	This silicon revision is available as TMX only.
B (second letter in prefix is a "B")	Indicates Revision 1.2	This silicon revision is available as TMX only.
C (second letter in prefix is a "C")	Indicates Revision 1.3	This silicon revision is available as TMS.
D (second letter in prefix is a "D")	Indicates Revision 1.4	This silicon revision is available as TMS.
F (second letter in prefix is a "F")	Indicates Revision 1.6	This silicon revision is available as TMS.
