基于 KeyStone 器件建立鲁棒性系统

摘要

对于复杂的系统，鲁棒性是非常重要的。为了协助客户建立鲁棒性系统，KeyStone 器件提供了多种硬件保护机制，如内存保护、EDC。本文介绍如何利用这些特性在 KeyStone 器件上建立一个鲁棒的系统。同时提供了与文档配套的例程。

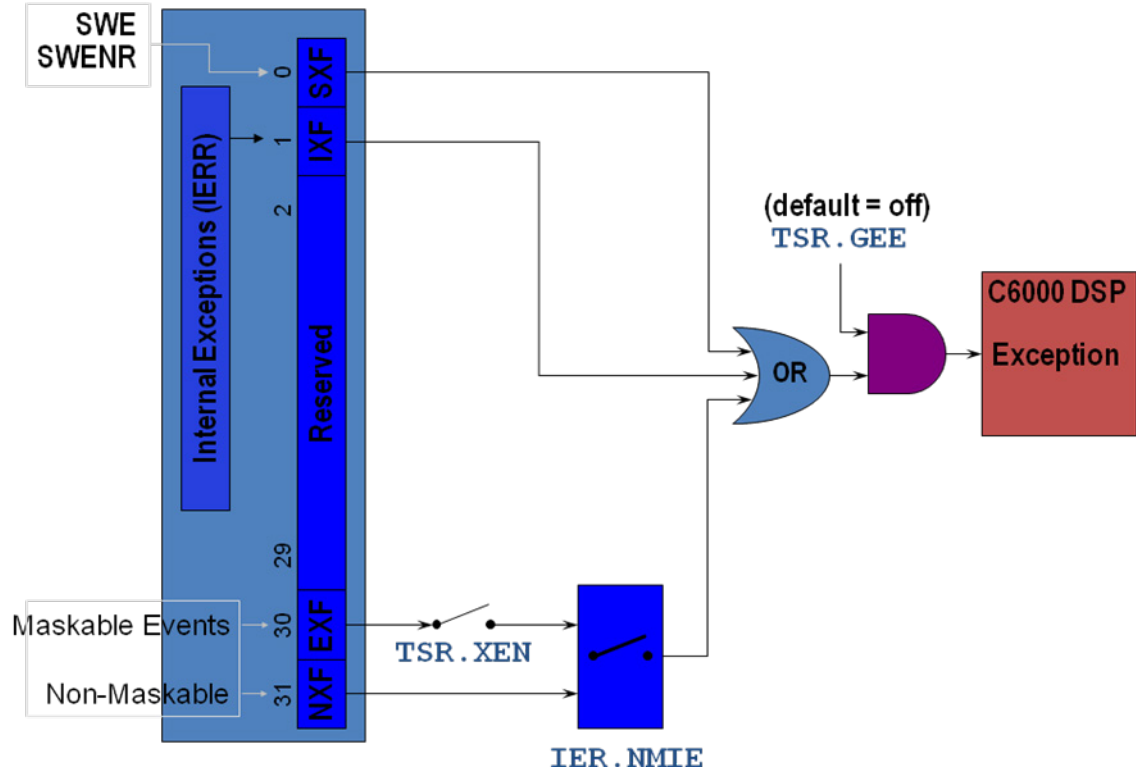
图 2 DSP 核异常控制开关

下图描述 DSP core 内部控制异常处理的开关。

一旦软件置位 TSR.GEE 及 IER.NMIE，不能再由软件清除，只能在复位后被清除。
