Errata

MSPM0L222x, MSPM0L122x, MSPM0L222x-Q1,  
MSPM0L122x-Q1 Microcontrollers

This document describes the known exceptions to the functional specifications (advisories).

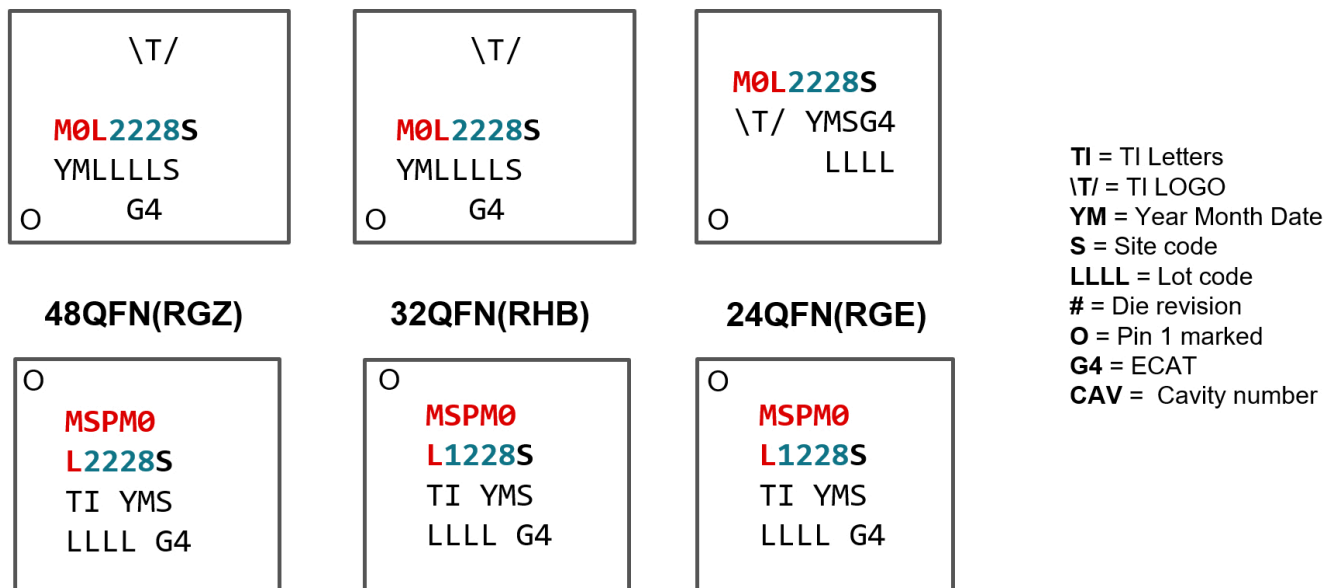
The package diagrams below indicate the package symbolization scheme, and [Table 5-1](#) defines the device revision to version ID mapping.

Figure 5-1. Package Symbolization
