TMS320VC5420
Digital Signal Processor
Silicon Errata

SPRZ169B
April 2000
Revised October 2001

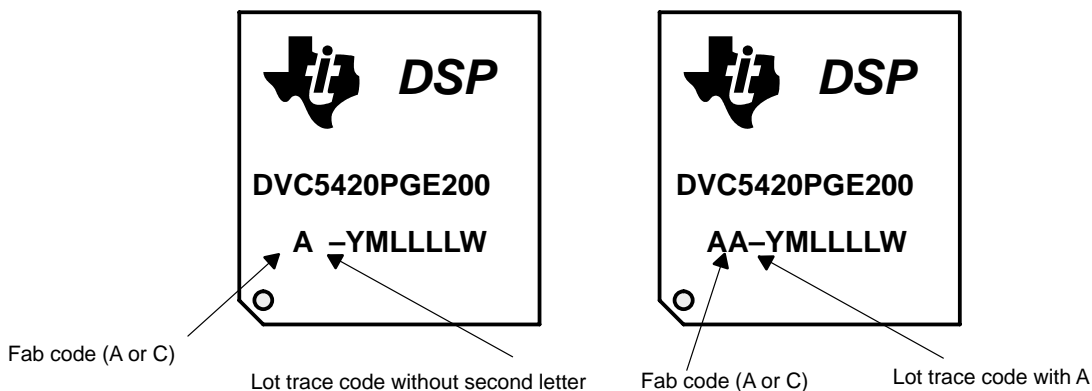
Figure 1. Example, Typical Lot Trace Code for TMS320VC5420 (PGE)

Lot Trace Code	Silicon Revision
Blank No second letter in the Lot Trace Code	Indicates Original Silicon
A as second letter in the Lot Trace Code	Indicates Silicon Revision A
B as second letter in the Lot Trace Code	Indicates Silicon Revision B
C as second letter in the Lot Trace Code	Indicates Silicon Revision C
D as second letter in the Lot Trace Code	Indicates Silicon Revision D
E as second letter in the Lot Trace Code	Indicates Silicon Revision E
F as second letter in the Lot Trace Code	Indicates Silicon Revision F. Revision F is functionally equivalent to Revision E

The device revision can be determined by the lot trace code marked on the top of the package. The locations for the lot trace codes for the PGE and the GGU packages are shown in Figure 1 and Figure 2, respectively. The location of other markings may vary per device.
