TMS320LC2406A, TMS320LC2404A, TMS320LC2402A

DSP Controllers

Silicon Errata

SPRZ185C
May 2001
Revised June 2004

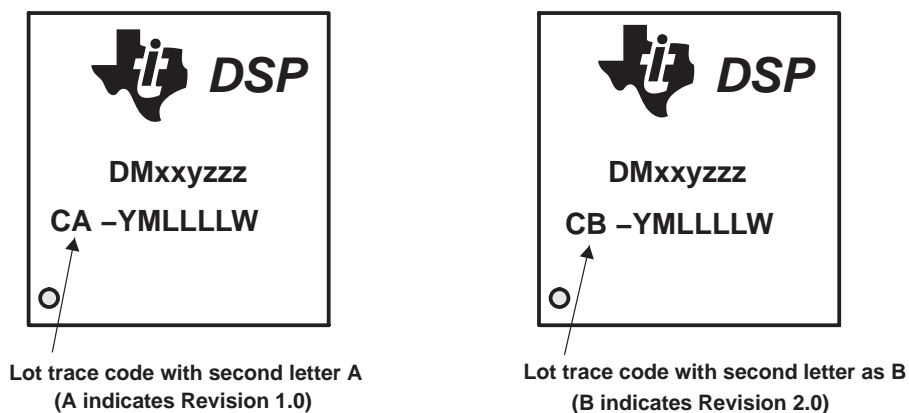
Figure 2. Example of Lot Trace Code for TMS320LC2404A/2402A

1.3 Revision Identification for TMS320LC2402A

Second Letter in Prefix of Lot Trace Code	Silicon Revision	Comments
A (Second letter in prefix)	Indicates Revision 1.0	This silicon revision is available as TMS.
B (First letter in prefix is a "C" and the second is an "B")	Indicates Revision 2.0	This silicon revision is available as TMS.
