# Errata

## **MSPM0G351x, MSPM0G151x, MSPM0G351x-Q1, MSPM0G3529-Q1 Microcontrollers**

This document describes the known exceptions to the functional specifications (advisories).

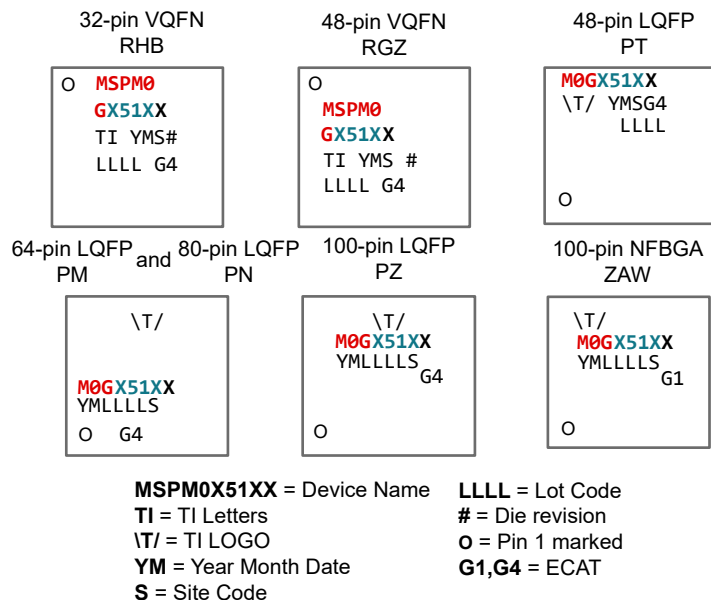
**Figure 5-1. Package Symbolization**

The package diagrams below indicate the package symbolization scheme, and [Table 5-1](#) defines the device revision to version ID mapping.
