# ***Avoiding Phantom Interrupts on the TMS470R1X Central Interrupt Module***

This application report describes the ways that phantom interrupts can occur on a TMS470R1x device and how to avoid them.

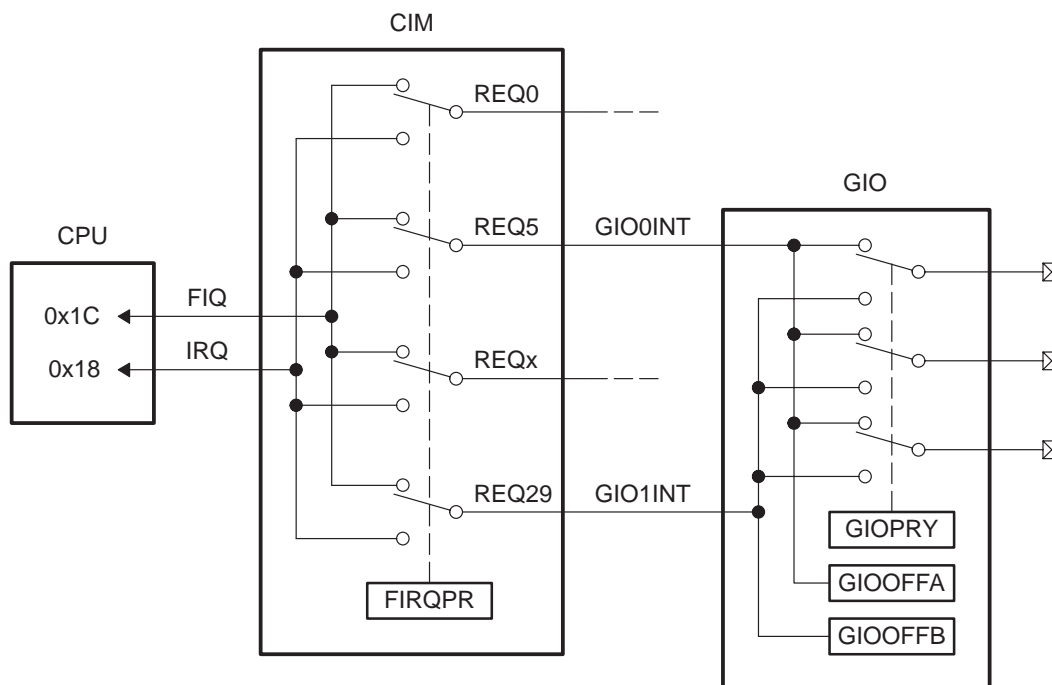
**Figure 1. CIM's Role in Generating Interrupts**

All the devices of the TMS470R1x family include the central interrupt module (CIM), which controls the generation of interrupts to the CPU if an interrupt is requested by one of the peripheral modules. See Figure 1.

All interrupts have a corresponding interrupt flag in the INTREQ register. A flag is set if an interrupt was requested by the peripheral module. To allow a fast determination of which module raised an interrupt request, three interrupt offset registers are implemented (IRQIVEC, FIQIVEC, CIMIVEC). IRQIVEC holds the offset of the highest priority IRQ, FIQIVEC holds the offset of the highest priority FIQ, and CIMIVEC holds the highest priority interrupt whether it is an FIQ or an IRQ.
