CC430F6135 Device Erratasheet

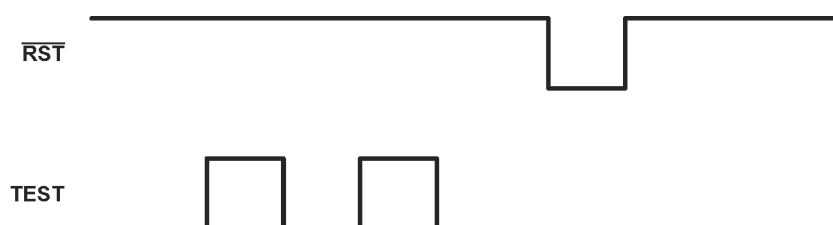
- Toggle the TEST pin twice when nRST is high and after 50us pull nRST low.

Note: This toggling of TEST pins is not subject to timing constraints. The appropriate level transitions on TEST pin, followed by a RST pulse after 50us, are sufficient to trigger an exit from BSL mode.
