# CC430F6137 Device Erratasheet

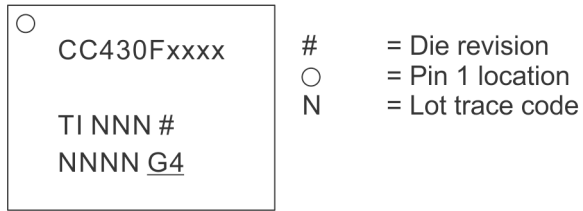
### QFN (RGC), 64 pin

### RGC64

The revision of the device can be identified by the revision letter on the [Package Markings](#) or by the [HW\\_ID](#) located inside the TLV structure of the device
